Examination of Route of Oil Migration and Screen the Source of Oil Contamination in External Wells near a Factory

Environmental Studies and Services Division, NBRO

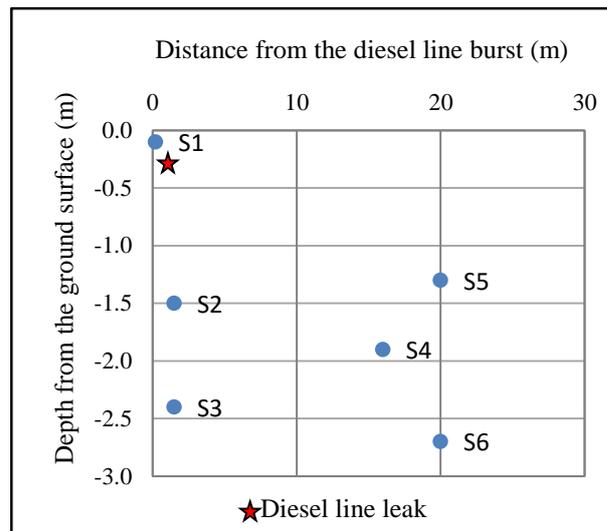
Fig. 1 Layout map of soil sampling locations

From these test pits soil samples (6) were taken at different depths from surface to ground and water table to detect oil and grease levels. (Fig.1- Layout diagram of soil sampling locations). Soil samples were taken in polythene bags which were previously rinsed with n-Hexane to analyse Oil and grease content using EPA-1664A.

- S1- from the surface near the diesel line burst
- S2 & S3- from Test Pit 1 (TP1)
- S4 & S5- from Test Pit (TP2)
- S6 from Test Pit 3 (TP3)

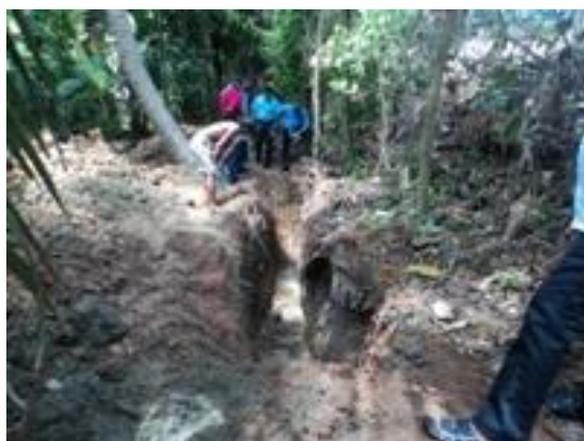
Test Pit No.	Location and observations
TP1	About 1.5m from the diesel line burst towards the sloping direction of the land. When excavating, floating oil was noted on the water table
TP2	About 16m from the diesel line burst opposite to the sloping direction and parallel to the underground diesel storage tank. When excavating floating oil was noted on the water table.
TP3	About 20m from the diesel line burst towards the sloping direction and is 1-2 from the highly contaminated well. When excavating floating oil was noted on the water table

Fig. 2 Showing excavated test pits

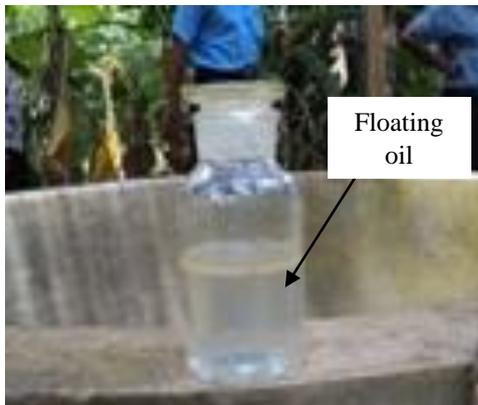
When NBRO has been requested to investigate the matter, at the site screening a leak in the diesel pipeline running parallel to the boundary wall of the factory was observed. The dark coloration in soils and smelling of mineral oil around the point of discharge inferred that the leak had been there for a long time. Also, it was noted that topography of the land is towards the contaminated wells. Floating oily like sheen was observed in wells and the levels decreased towards the wells located at the direction of sloping land.

Fig.3 Sample of well water appearing floating oil

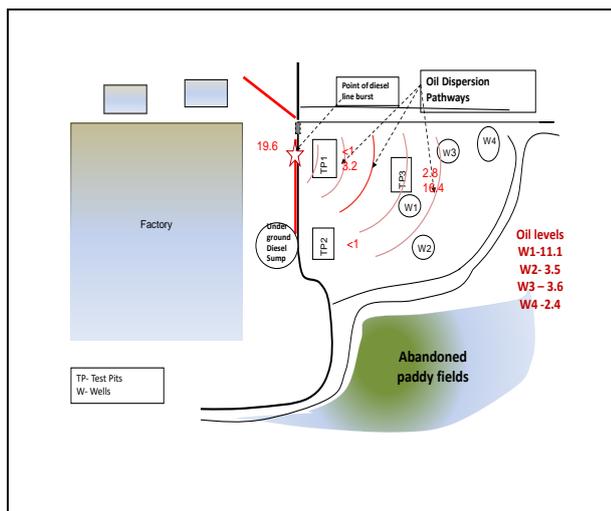
Fig.4 Layout map showing location of well, test pits and contaminant migration pathway

Accordingly, the highest levels were observed near the soil collected from the burst pipeline. Next highest is observed from the soil sample collected from the test pit dug near highly contaminated well. Through the oil levels it was justified that contaminant has reached the ground water table. Contaminant levels were higher in deeper soils than the shallow layers towards the sloping direction away from the spill. This suggests that the contaminant movement in the soil has migrated both horizontal and vertical directions. The findings further inferred that oil has been releasing and contaminating the groundwater for a long period and contaminated oil has been migrated at the soil-water interphase in deeper soil layers along the sloping direction. (Fig.4 Layout map showing location of well, test pits and contaminant migration pathway)

The study confirmed that the leaking diesel oil has been spreading over several dimensions in the vadose and phreatic zones finally contaminating the neighboring domestic water wells. The leak has been left unnoticed over longer period by the company has resulted release of substantial quantity of oil into the environment which could have prevented if the leak was observed early. In Sri Lanka the enforcement of environmental regulations in operating factories depend largely on

Soon upon conformation of contamination, the company initiated a full strength remediation by pumping out the groundwater and separation of oils, excavation of contaminated soil and treatment with dispersant. The families affected were given with clean drinking water and compensation for the damage caused.
