GEOTECHNICAL ASSESSMENT ON THE FAILURE AT MEETHOTAMULLA WASTE FILL

May, 2017

National Building Research Organisation

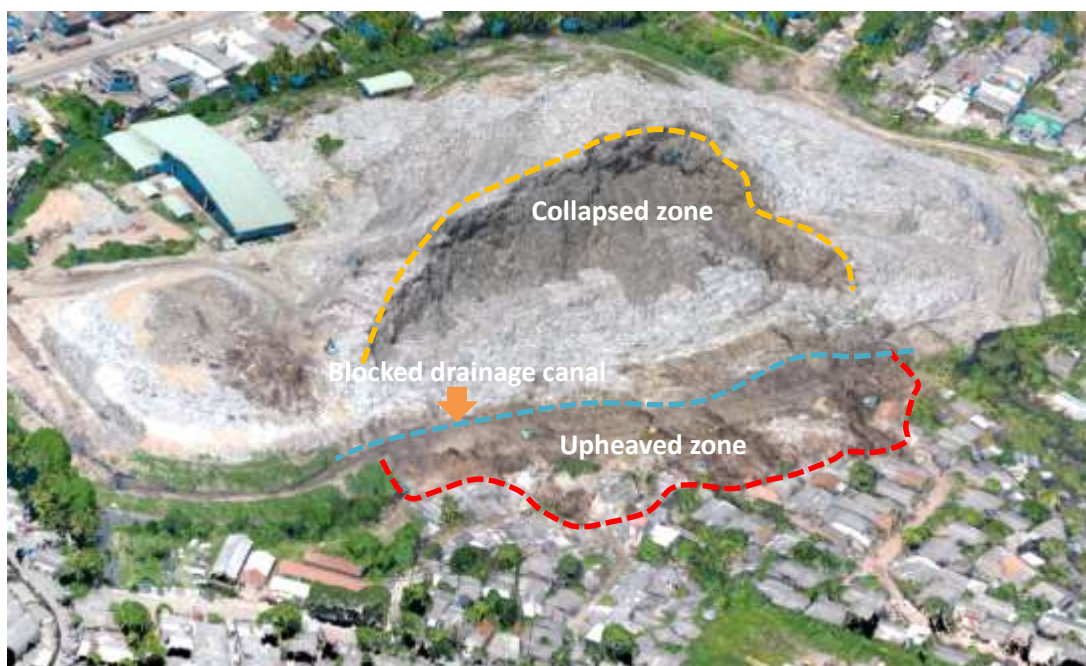
Figure 1: Aerial image indicating the failure face of the waste fill

According to the eye witnesses the collapse had taken place initially as a progressive failure followed by an accelerated movement and then it had come rest while smashing a section of South Western (SW) toe area. At the time of investigations there were no notable movements of waste or ground.

The on-site observations and aerial images after the incident show that a part of SW side slope of the waste fill had collapsed at its crest height, and the collapsed mass had almost moved down and subsided, while the toe region of the slope had upheaved (**Figure 1**). Furthermore, the collapse had made the SW canal section completely blocked due to lateral movement and ground upheaving. This was causing minor flood situation by blocking the flow from East to West, and as a result the houses at the South East (SE) side were partially inundated.

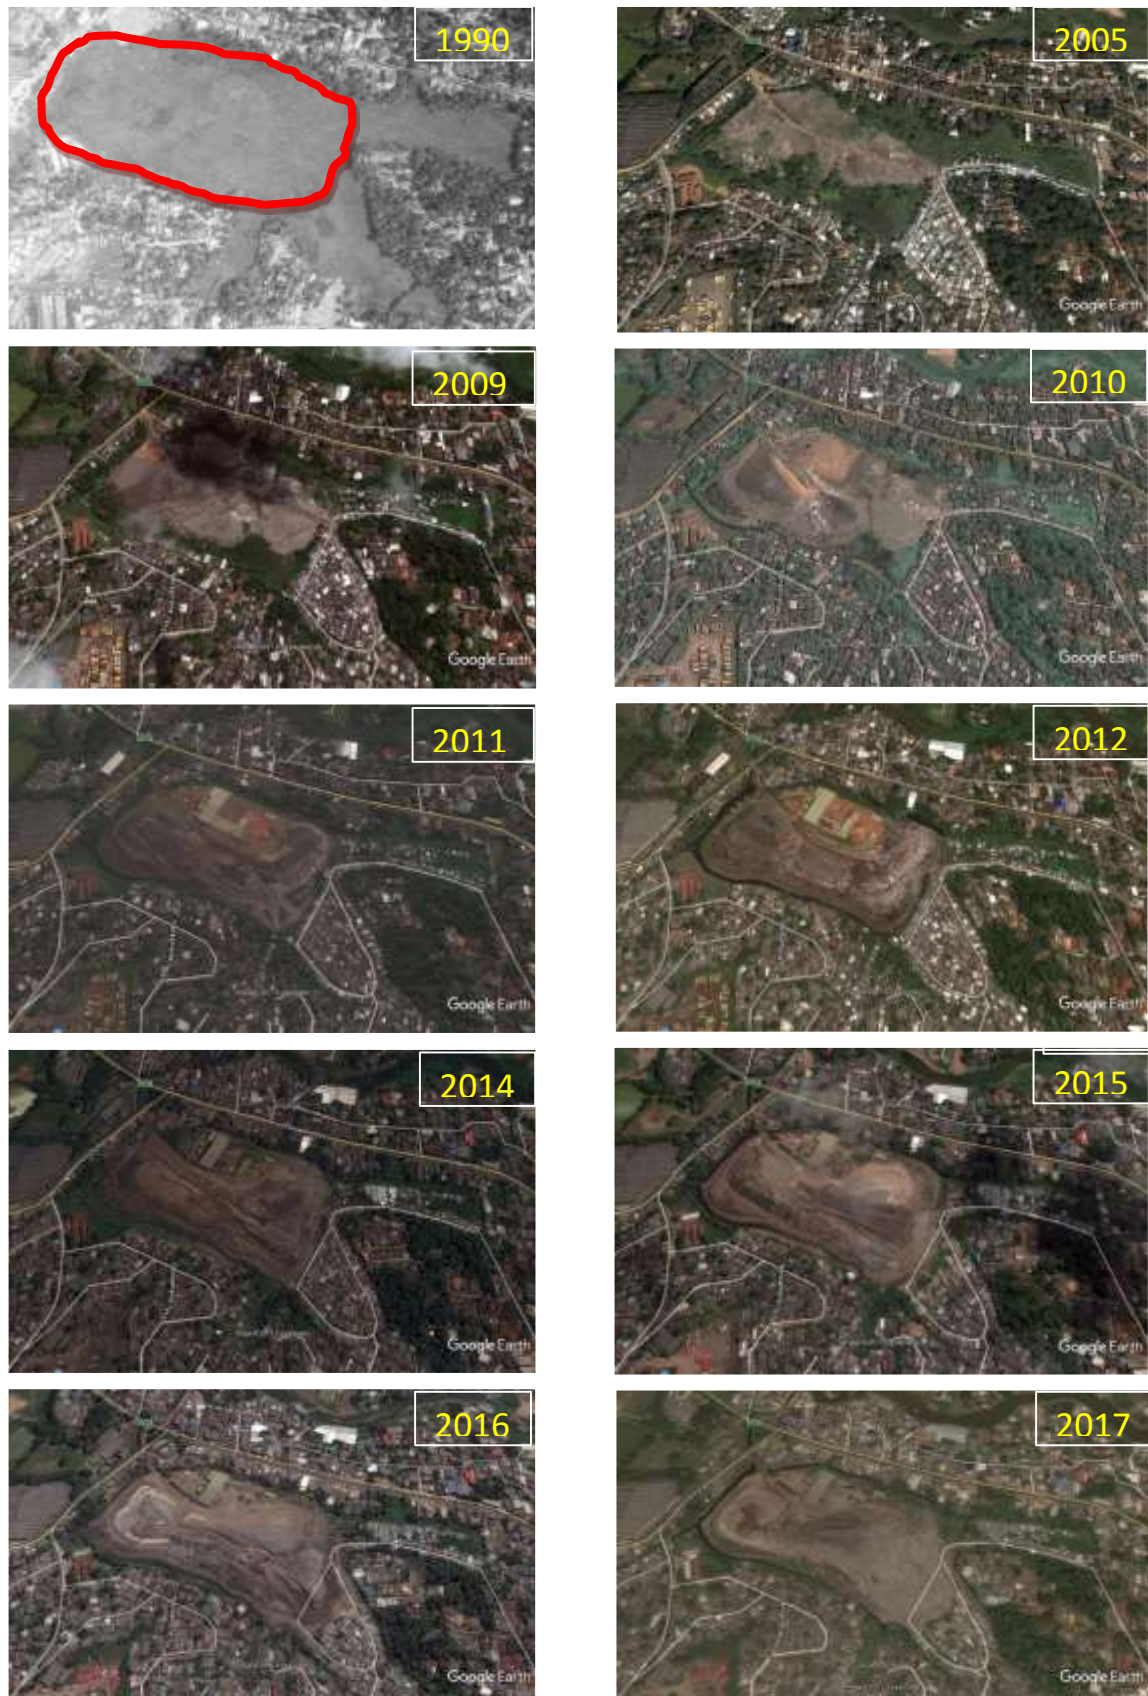
Figure 3: Aerial photo and Google images at the site showing lateral expansion of the waste fill from 1990-2017: Note marshy ground in 1990 and progressive expansion of waste load and occupations of marsh by settlements over the time

The aerial imagery shows that before 1990, this location had been a low-lying, marshy ground (**Figure 3**). At this time the terrain had been almost flat, and there was no indication of inhabitants within the area marked by the red line in the **Figure 3**.

The analysis of previous records at this site reveals that the site had been used for waste dumping even before 1998. With the urban growth and rapid development, the location has been receiving waste in increasing amounts in subsequent years. Initially, the site had received waste only from the Kolonnawa area. But, due to the closure of the Bloemendhal solid waste dump, the waste of Colombo Municipal Council area was also dumped at the site.

According to the Colombo Municipal Council, at the time of disaster, approximately 800-900 tons of waste were being dumped at the site daily. Over the time, people have settled in the area by gradually filling the marshland. The Google images of the site in Figure 3 show the lateral expansion of the waste fill and occupation of the marshland by houses over the time since 1990.

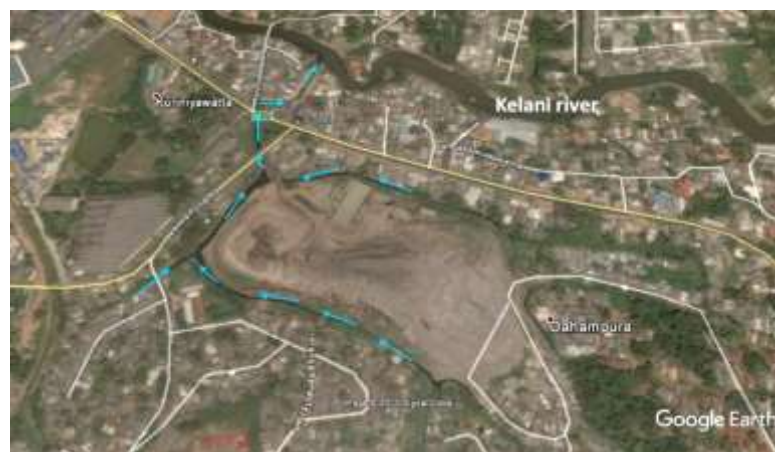
Figure 5: Surface drainage network in the site area

In 2016, most parts of the surrounding area of waste fill were completely inundated by heavy floods due to an extreme precipitation event. The storm water drainage has been a problem, as most of the reclaimed low-lying areas have no satisfactory gradient to facilitate natural drainage. The rate of water flow has reduced due to existing bottle neck places

especially in culvert locations, resulting water logged condition generally throughout the year. The **Figure 5** shows the drainage system in the site area.

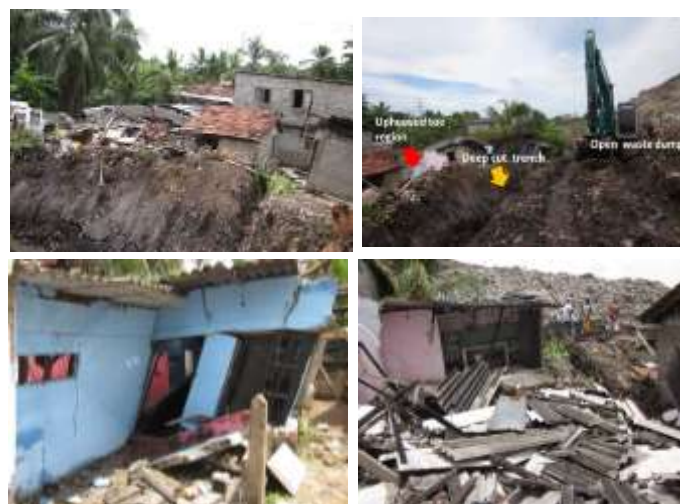
Figure 6: Ground movement and damages to houses due to deepening of the drainage canal; which removed toe support in the toe region at the South-West section in Oct 2012: Source: NBRO: 2013

Collapse of houses and flooding in the SW section of the toe area of the waste fill had been reported in 10th October 2012. The canal, which was situated at the toe of SW slope had been deepened and widened to drain storm water which has inundated the houses during rain, and that could have initiated the failure. Due to this, the houses in the toe area had tilted, cracked and collapsed (**Figure 6**). At this time the height of the waste fill was about 28 m. (*Refer Detailed soil investigation for solid waste disposal site at Meethotamulla – February 2013*)

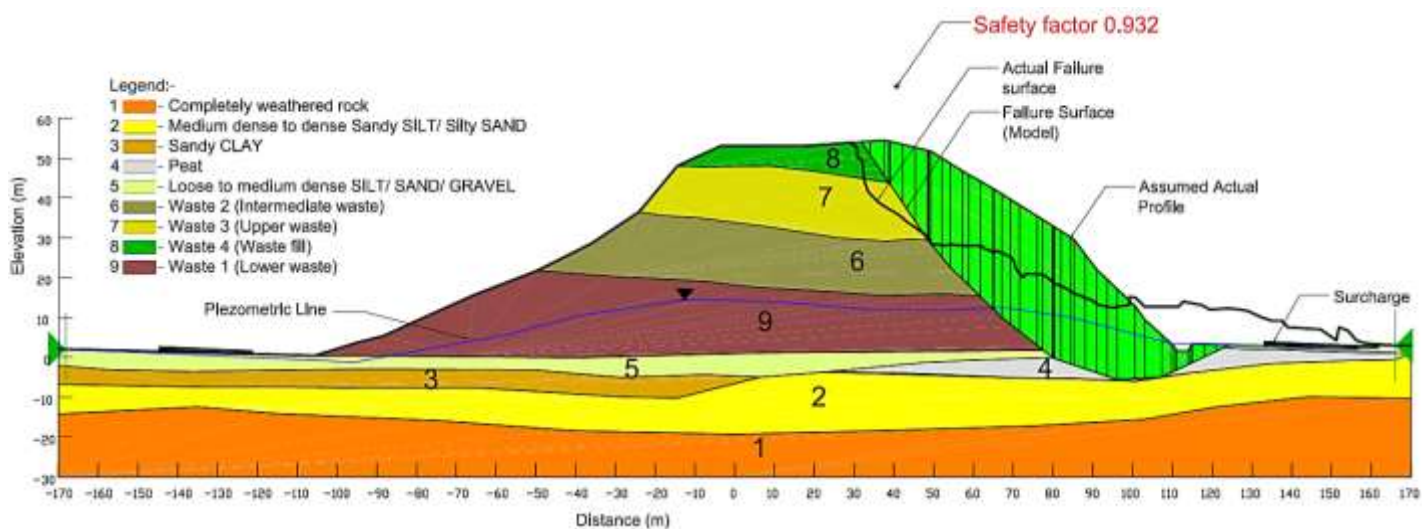
Figure 10: Results from Stability Analysis done for Section B-B

The applicability of the model was checked by carrying out an analysis for the full cross-section along Section B-B (**Figure 10**). Stability analysis was carried out by considering the generated cross-section and assumed material properties given in the section 4.2 and 4.3. The results indicate that the instability occurs at the Right Hand Side (RHS) of the section (where exact failure took place) and further, the failure predicted by the model conforms to the actual failure condition. Therefore, the model seems to be capable for analyzing the section with the assigned parameters of the sub-soil and waste.

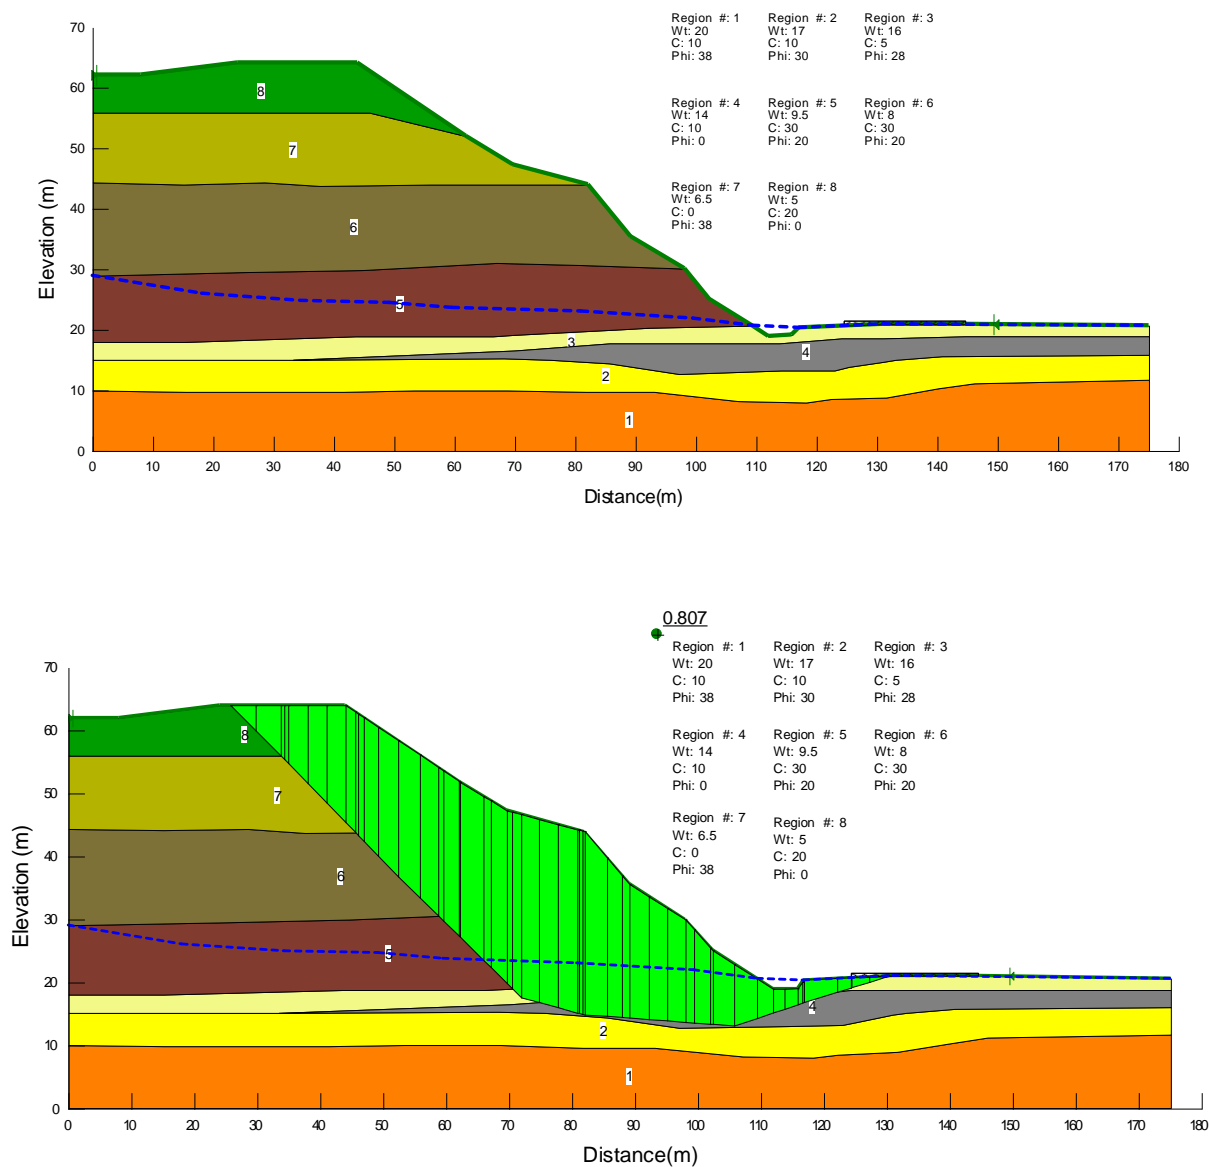
Figure II: Stability analysis for section A-A

The results clearly show that low factor of safety of 0.807 and 0.932 are at the failed sections A- A and B-B respectively.

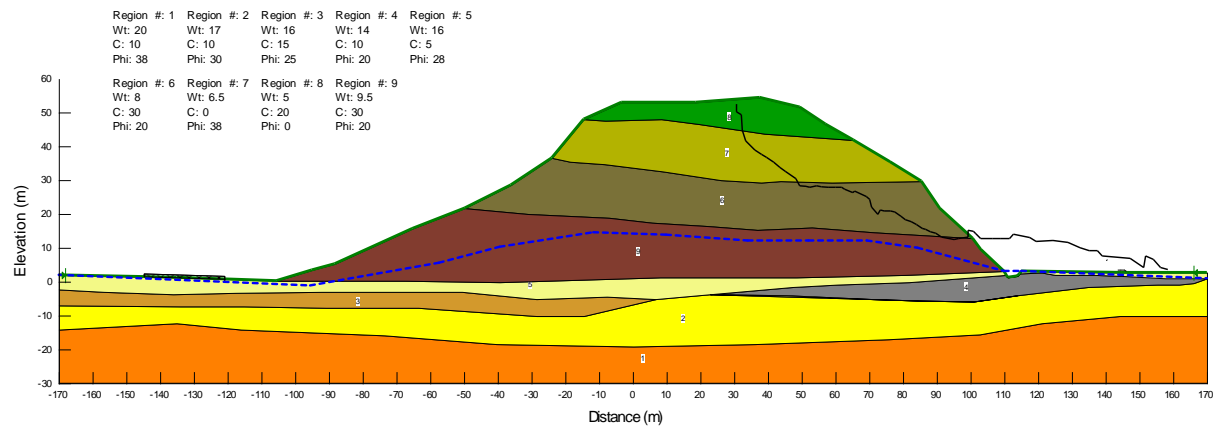
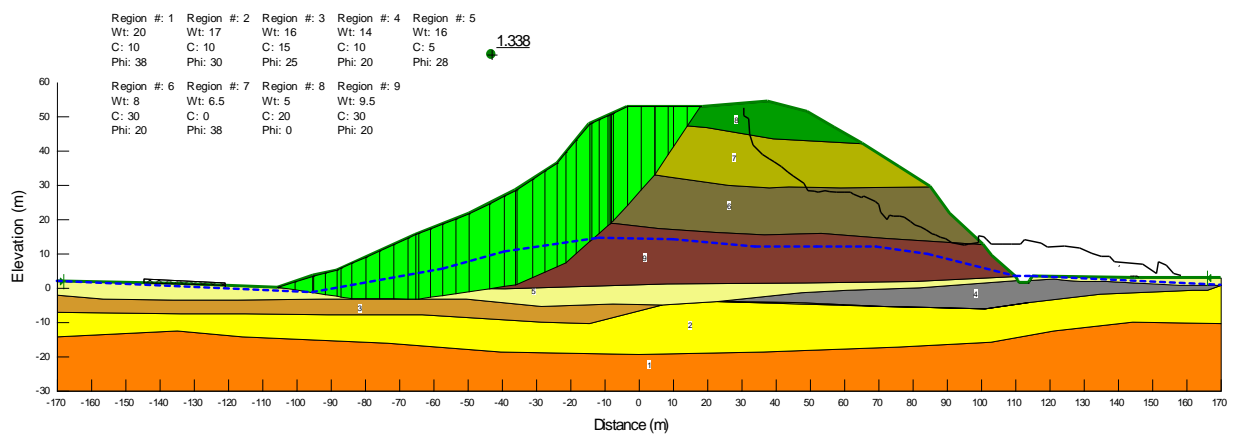
Figure IV: Stability analysis for section B-B LHS

According to the results, Section D-D and LHS of the Section B-B stay at stable condition relative to the other sections with higher factor of safety greater than 1.25.

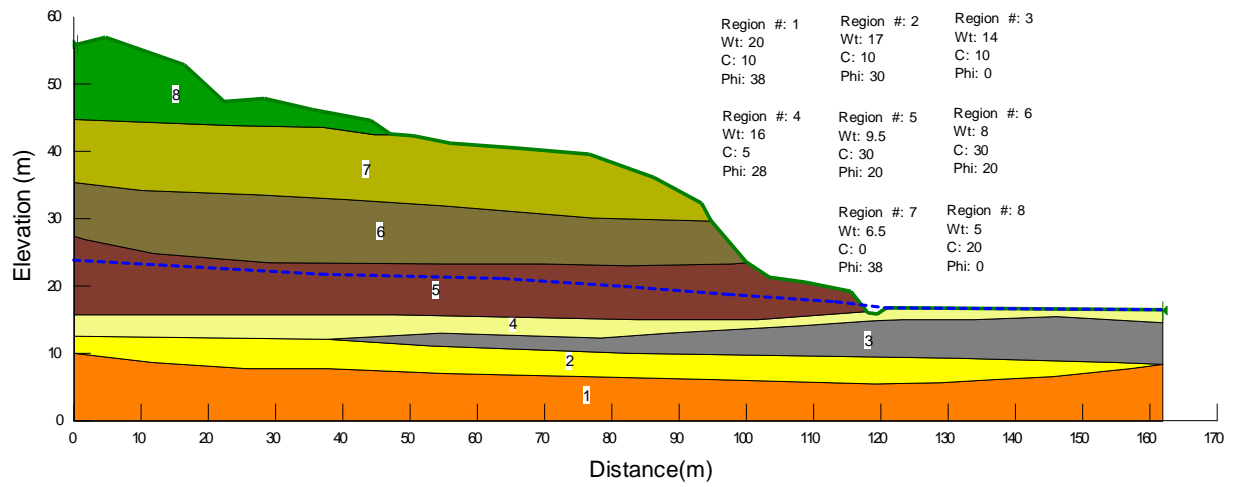
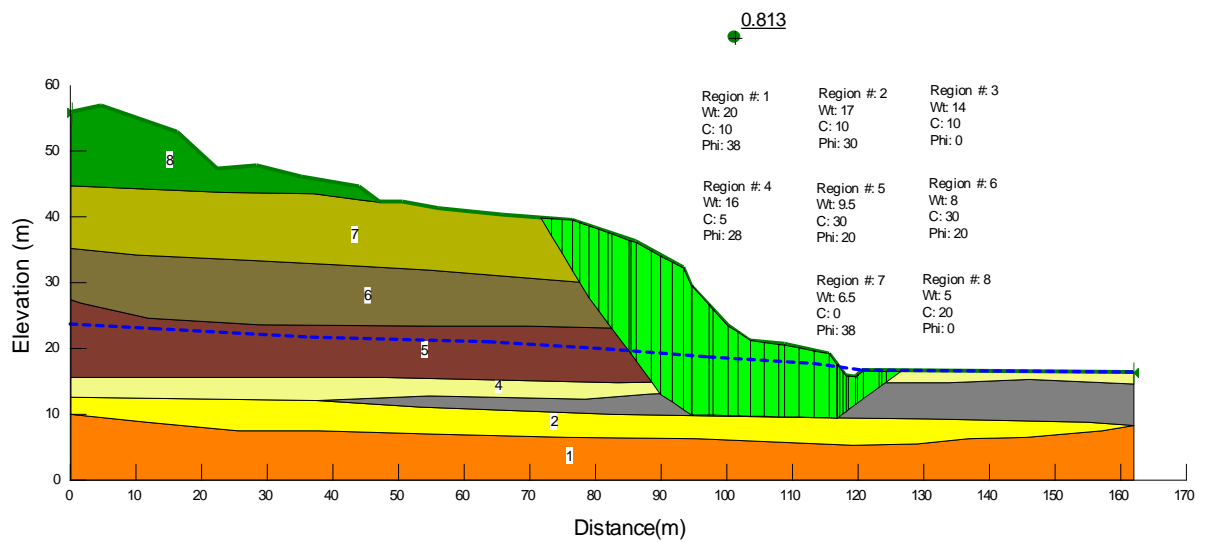
Figure V: Stability analysis for section C-C

In addition, the factor of safety of 0.813 calculated for the section C-C revealed that section C-C is also at unstable condition. Therefore, if the load imposed on the slope C-C is increased by further waste dumping or due to rapid rainwater infiltration, it may become unstable and collapse.

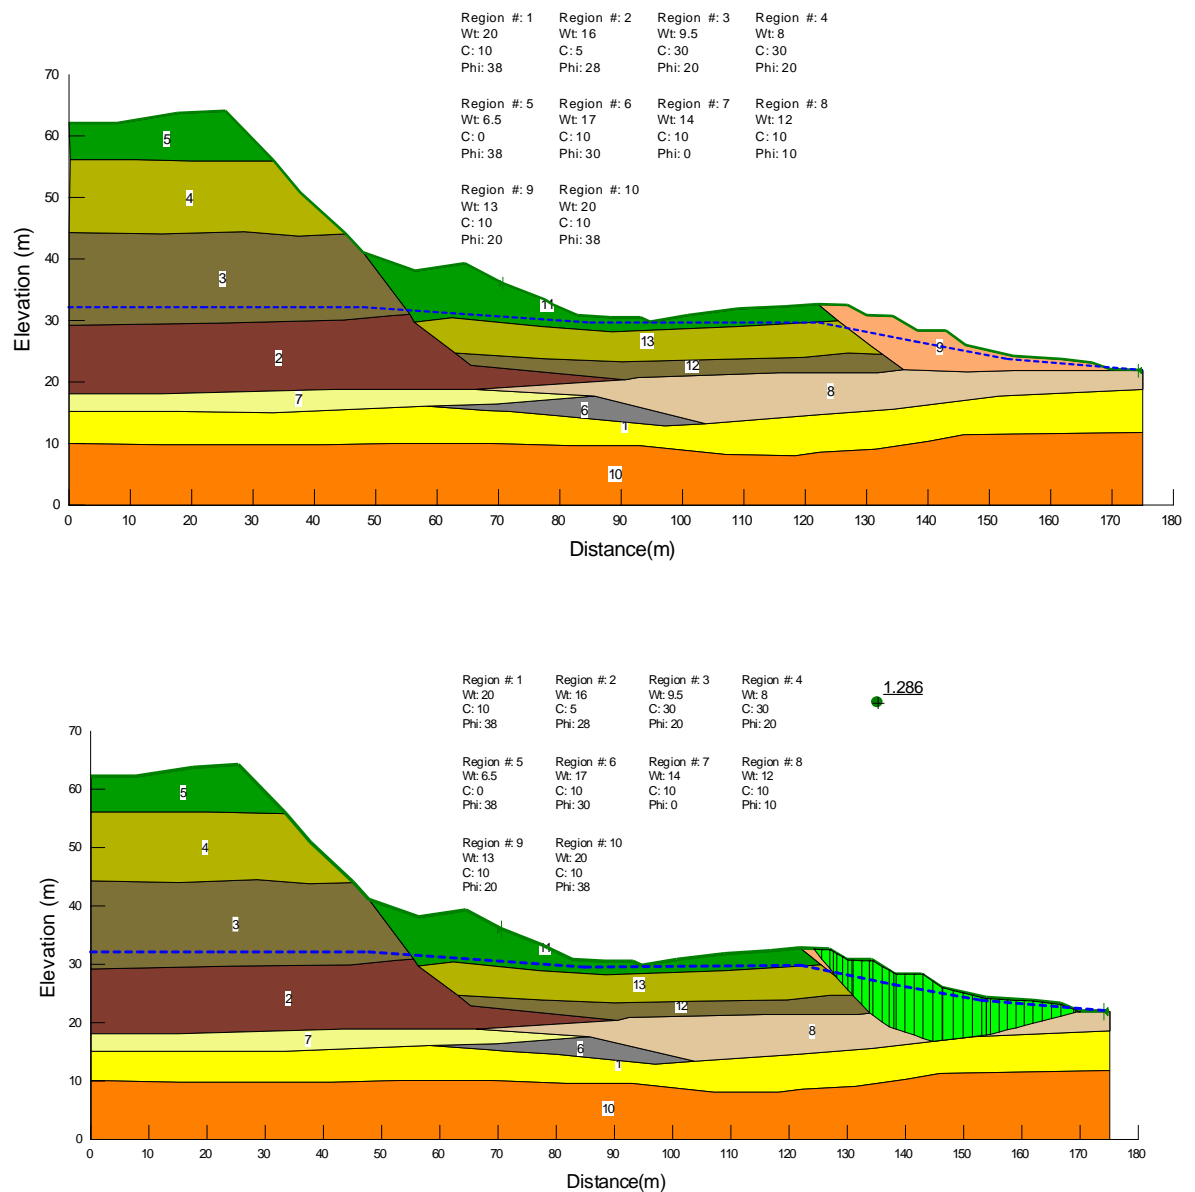
Figure VII: Stability analysis for section A-A – Current situation

Moreover, the remediation work such as construction of earth berms in the toe area of the failed section and improvement of drainage have increased the stability of the failed section by a factor of 1.287 (**Annexure 2 – Figure VII**).
