# **GEOTECHNICAL ASSESSMENT ON THE FAILURE AT MEETHOTAMULLA WASTE FILL**

**May, 2017**

**National Building Research Organisation**

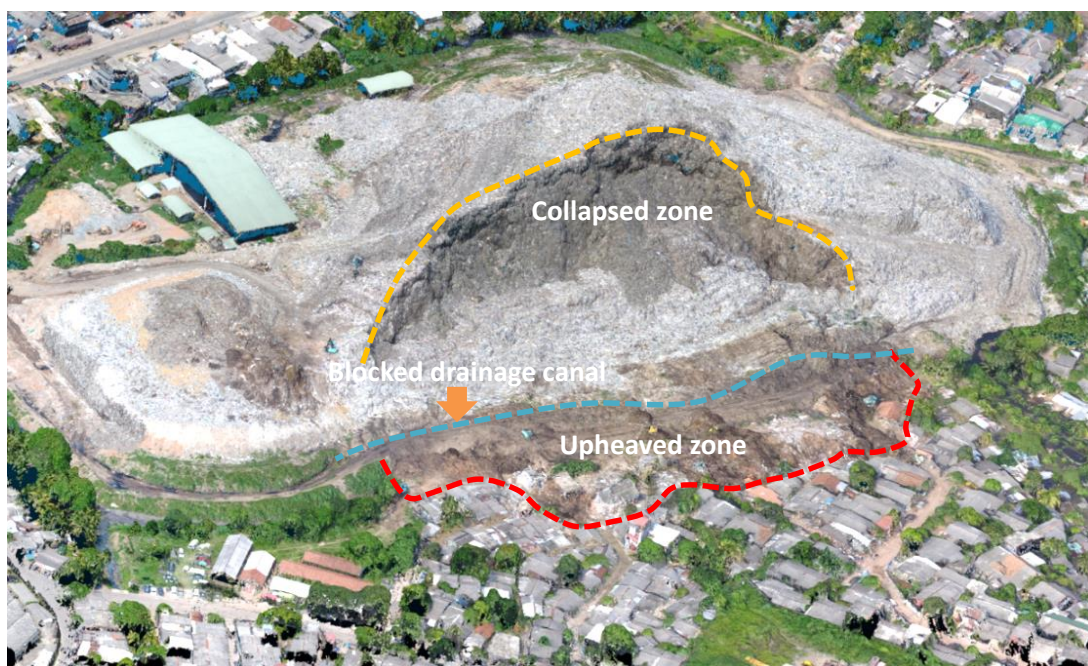
*Figure 1: Aerial image indicating the failure face of the waste fill*

According to the eye witnesses the collapse had taken place initially as a progressive failure followed by an accelerated movement and then it had come rest while smashing a section of South Western (SW) toe area. At the time of investigations there were no notable movements of waste or ground.

The on-site observations and aerial images after the incident show that a part of SW side slope of the waste fill had collapsed at its crest height, and the collapsed mass had almost moved down and subsided, while the toe region of the slope had upheaved (**Figure 1**). Furthermore, the collapse had made the SW canal section completely blocked due to lateral movement and ground upheaving. This was causing minor flood situation by blocking the flow from East to West, and as a result the houses at the South East (SE) side were partially inundated.

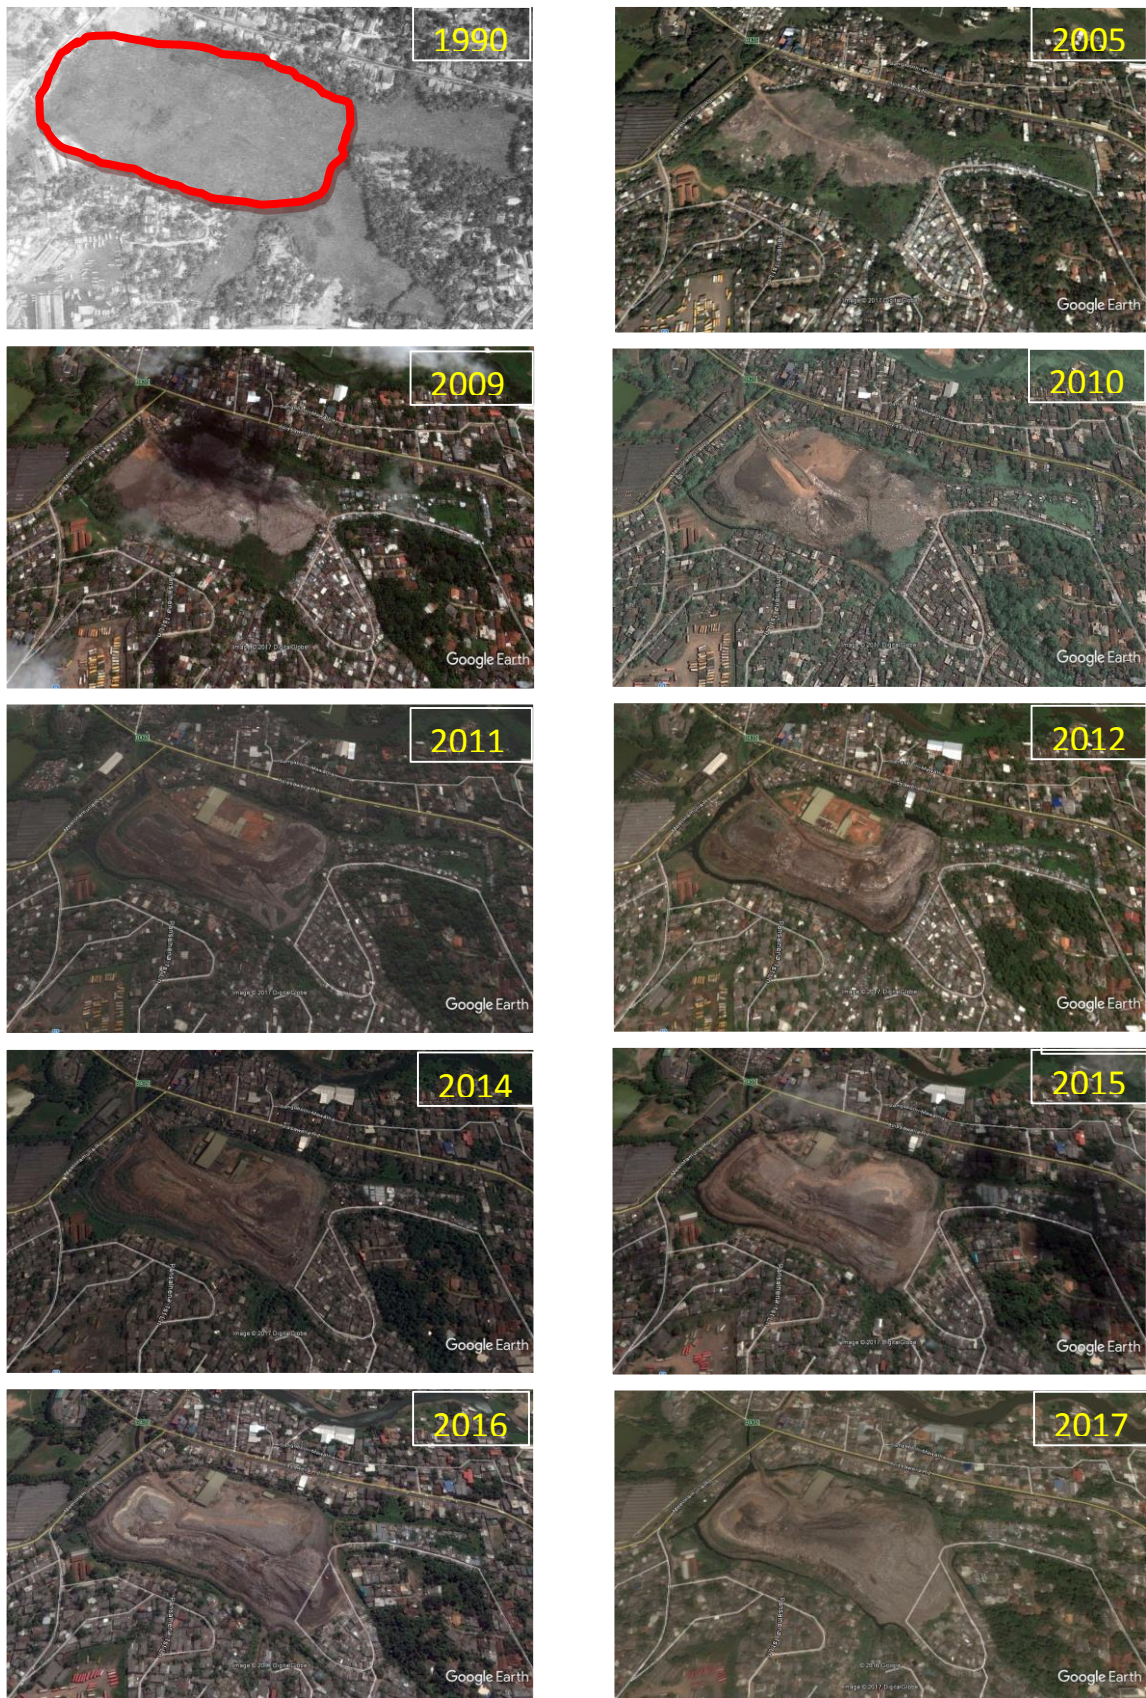
The aerial imagery shows that before 1990, this location had been a low-lying, marshy ground (**Figure 3**). At this time the terrain had been almost flat, and there was no indication of inhabitants within the area marked by the red line in the **Figure 3**.

*Figure 3: Aerial photo and Google images at the site showing lateral expansion of the waste fill from 1990-2017: Note marshy ground in 1990 and progressive expansion of waste load and occupations of marsh by settlements over the time*

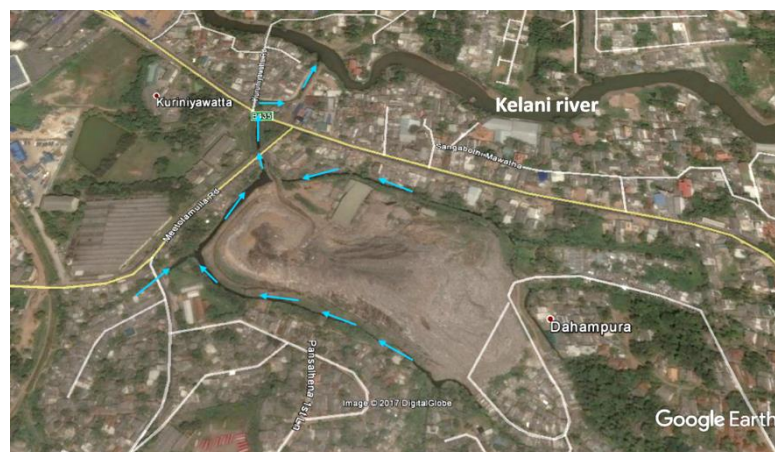
Figure 5: Surface drainage network in the site area

In 2016, most parts of the surrounding area of waste fill were completely inundated by heavy floods due to an extreme precipitation event. The storm water drainage has been a problem, as most of the reclaimed low-lying areas have no satisfactory gradient to facilitate natural drainage. The rate of water flow has reduced due to existing bottle neck places

especially in culvert locations, resulting water logged condition generally throughout the year. The **Figure 5** shows the drainage system in the site area.

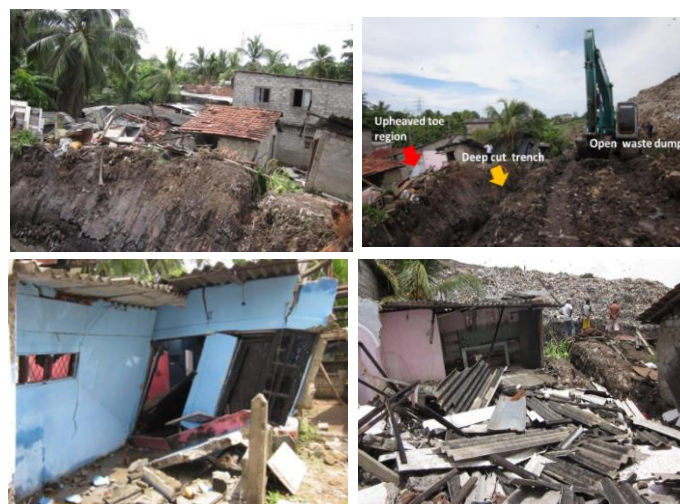
Collapse of houses and flooding in the SW section of the toe area of the waste fill had been reported in 10th October 2012. The canal, which was situated at the toe of SW slope had been deepened and widened to drain storm water which has inundated the houses during rain, and that could have initiated the failure. Due to this, the houses in the toe area had tilted, cracked and collapsed (**Figure 6**). At this time the height of the waste fill was about 28 m. (Refer Detailed soil investigation for solid waste disposal site at Meethotamulla – February 2013)

Figure 6: Ground movement and damages to houses due to deepening of the drainage canal; which removed toe support in the toe region at the South-West section in Oct 2012: Source: NBRO: 2013

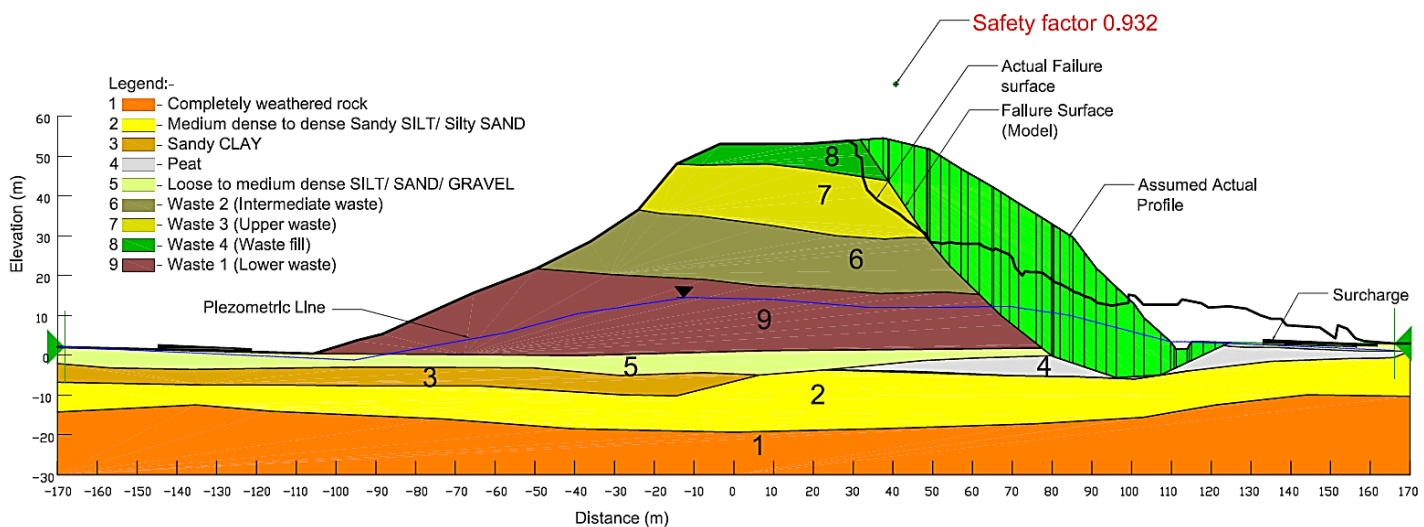
Figure 10: Results from Stability Analysis done for Section B-B

The applicability of the model was checked by carrying out an analysis for the full cross-section along Section B-B (Figure 10). Stability analysis was carried out by considering the generated cross-section and assumed material properties given in the section 4.2 and 4.3. The results indicate that the instability occurs at the right hand side (RHS) of the section (where exact failure took place) and further, the failure predicted by the model conforms to the actual failure condition. Therefore, the model seems to be capable for analyzing the section with the assigned parameters of the sub-soil and waste.

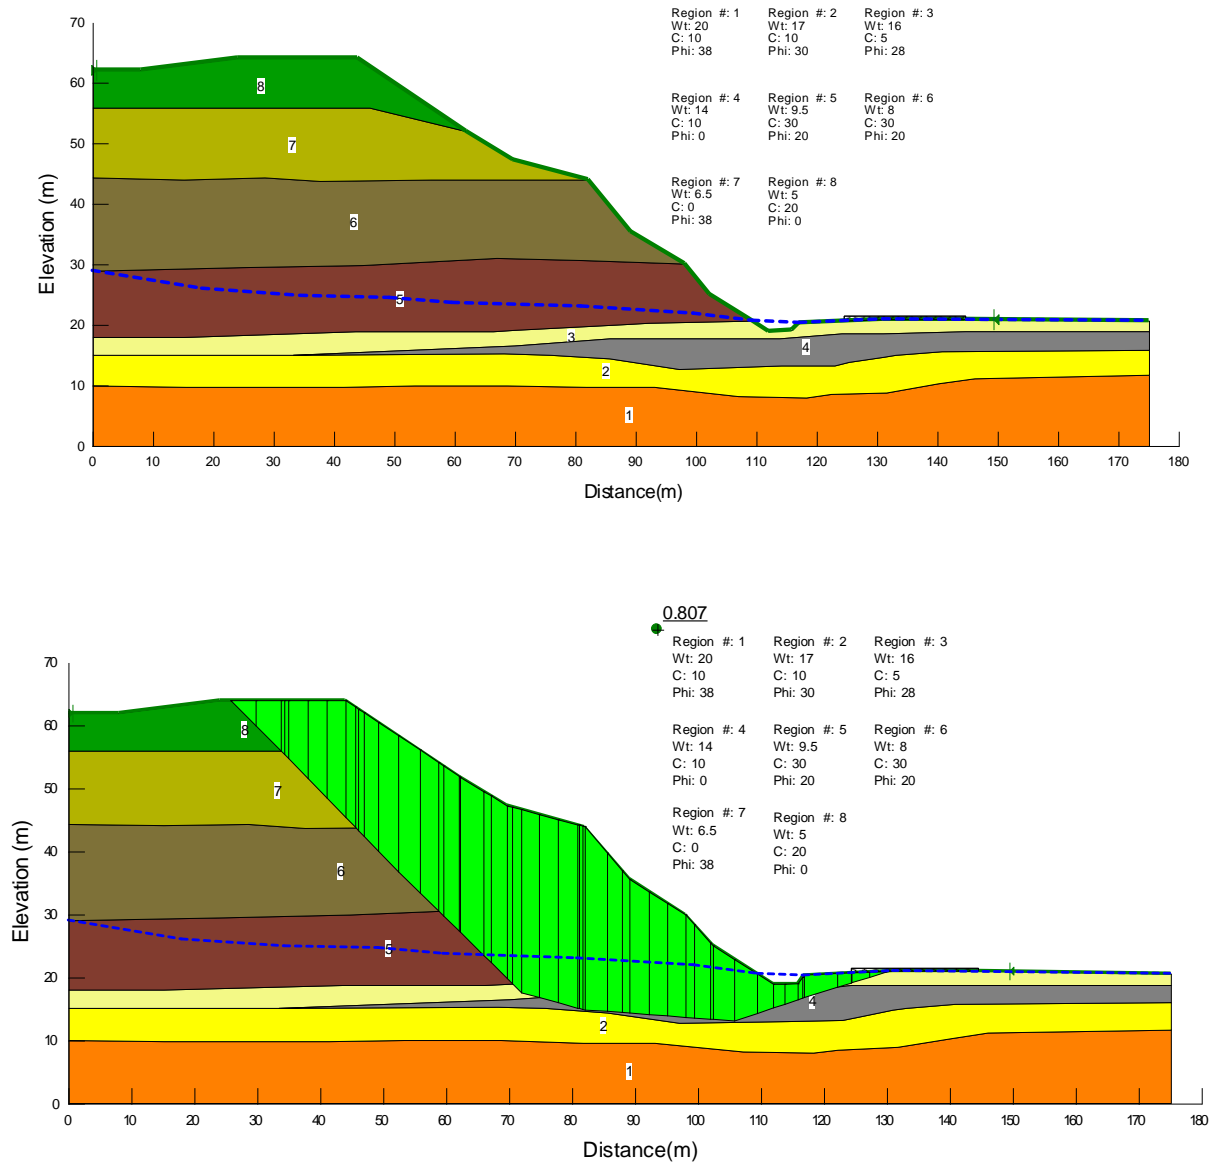
**Figure II: Stability analysis for section A-A**

The results clearly show that low factor of safety of 0.807 and 0.932 are at the failed sections A- A and B-B respectively.

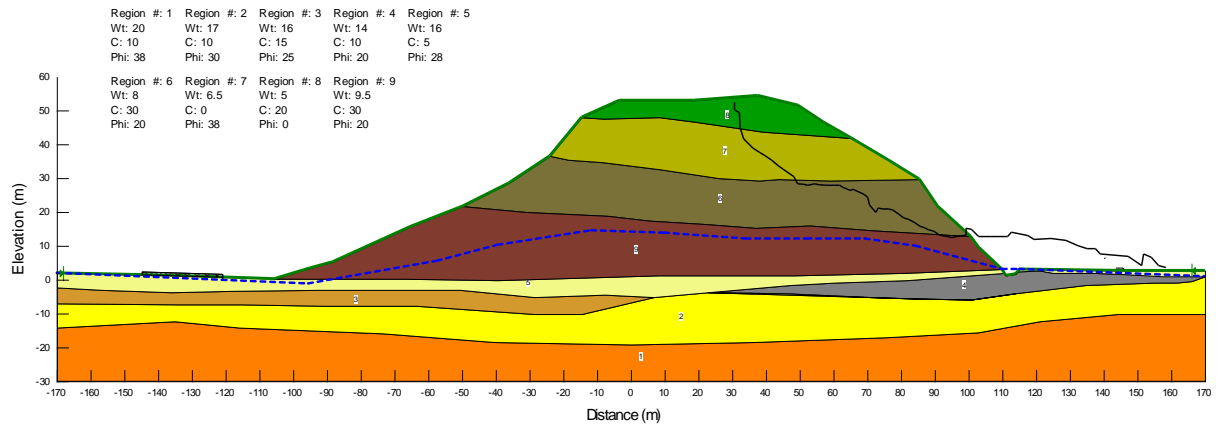
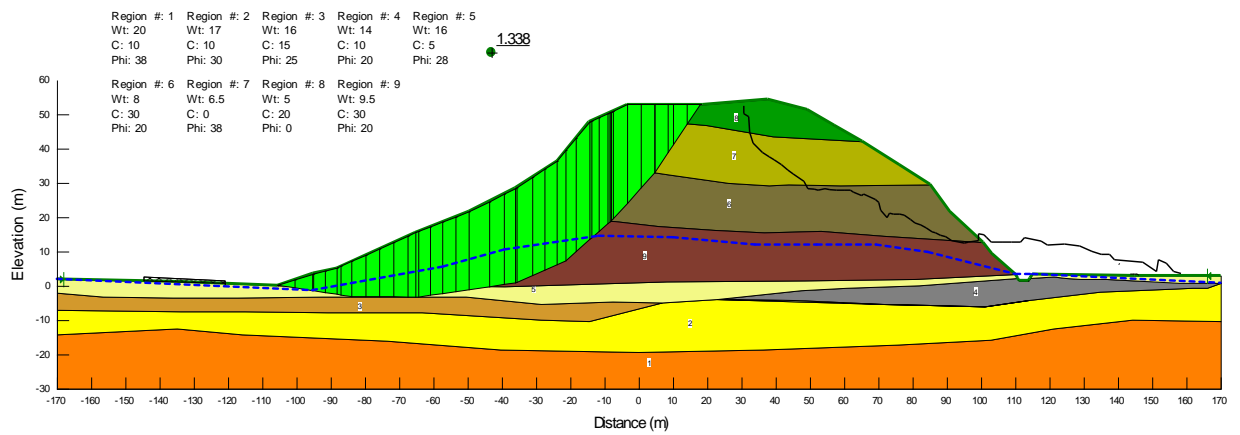
**Figure IV: Stability analysis for section B-B LHS**

According to the results, Section D-D and LHS of the Section B-B stay at stable condition relative to the other sections with higher factor of safety greater than 1.25.

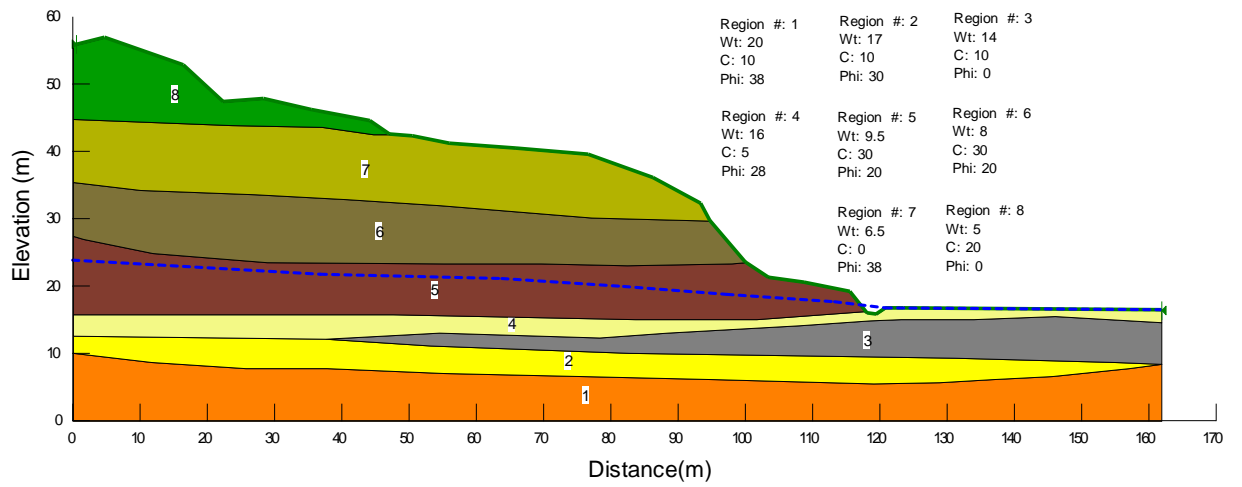
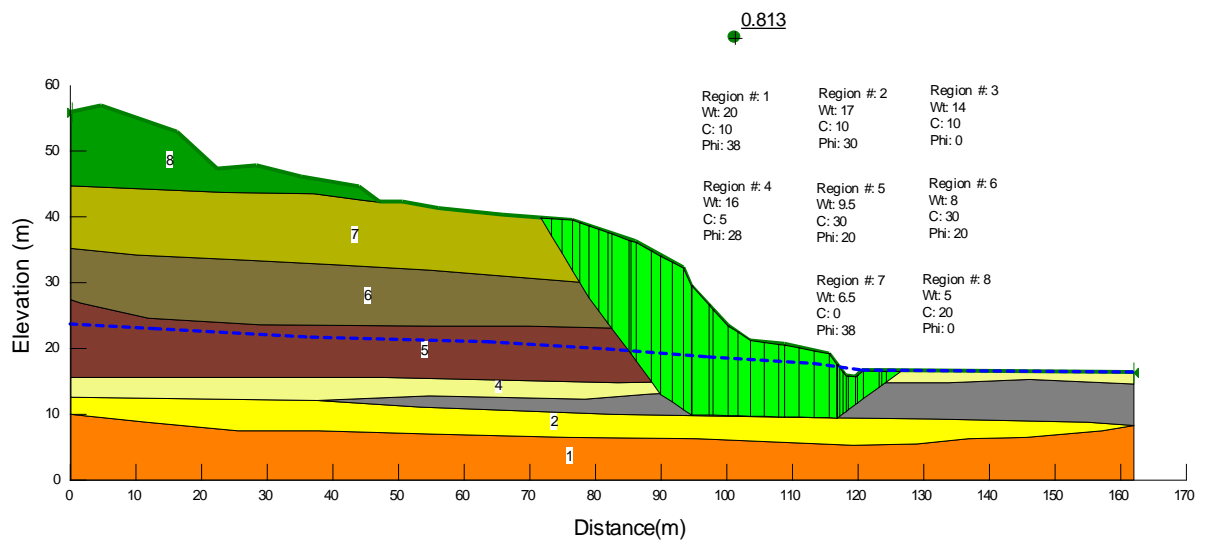
*Figure V: Stability analysis for section C-C*

In addition, the factor of safety of 0.813 calculated for the section C-C revealed that section C-C is also at unstable condition. Therefore, if the load imposed on the slope C\_C is increased by further waste dumping or due to rapid rainwater infiltration, it may become unstable and collapse.

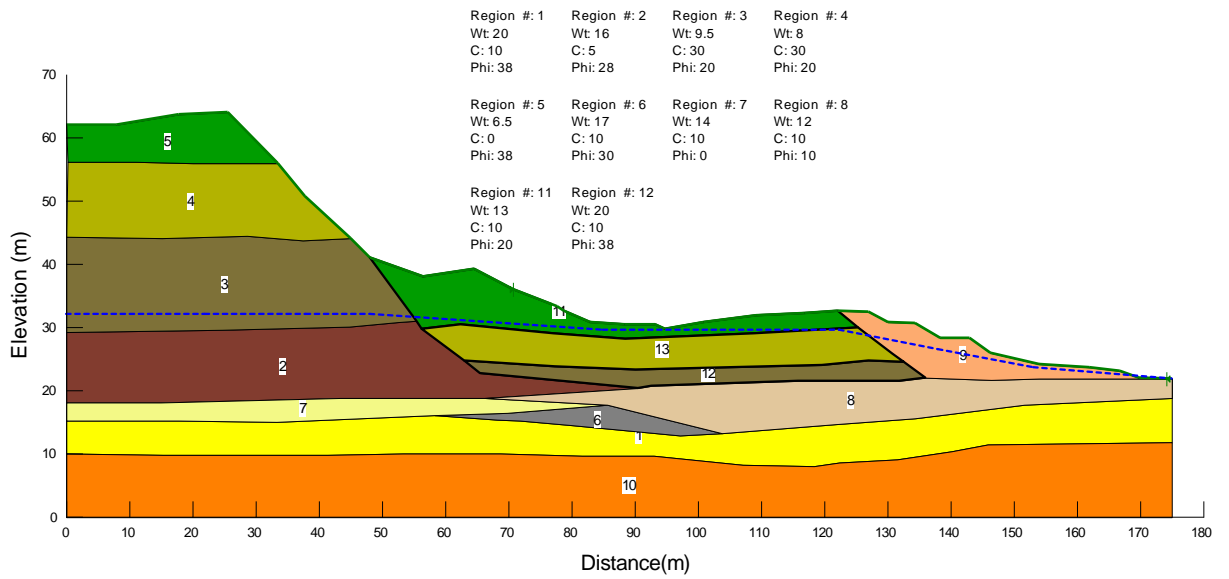
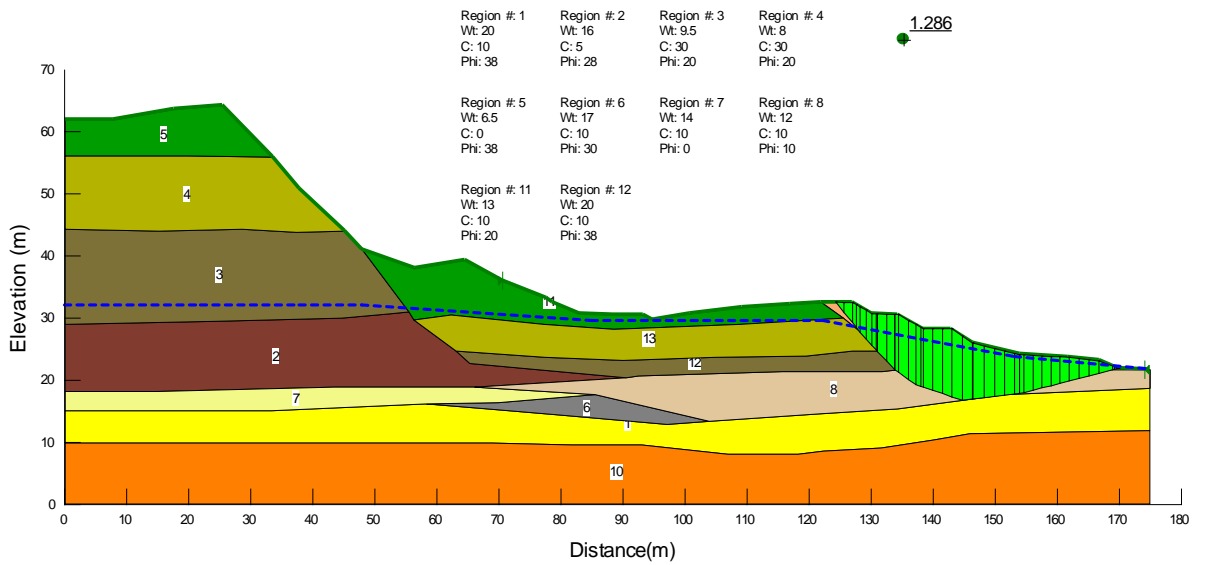
*Figure VII: Stability analysis for section A-A – Current situation*

Moreover, the remediation work such as construction of earth berms in the toe area of the failed section and improvement of drainage have increased the stability of the failed section by a factor of 1.287 (**Annexure 2 – Figure VII**).
