Newsletter

Volume : 37
December 2016

Technical Co-operation for Landslide Mitigation Project

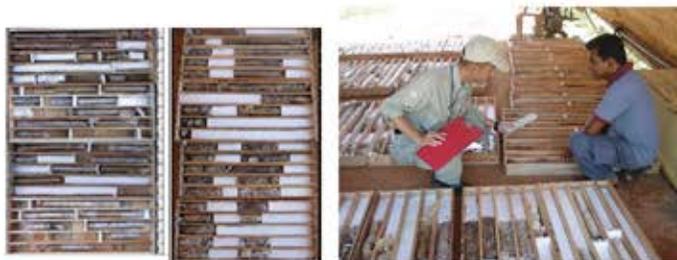
Core recovered from existing techniques (40% recovery) Core recovered from the new rig (60% recovery) Japanese expert assistance in core sample inspection

There is much room to improve, and the core samples from the new machine from borehole No 6 at pilot site Badulusirigama with a significant increase in recovery could be considered as a good sign.

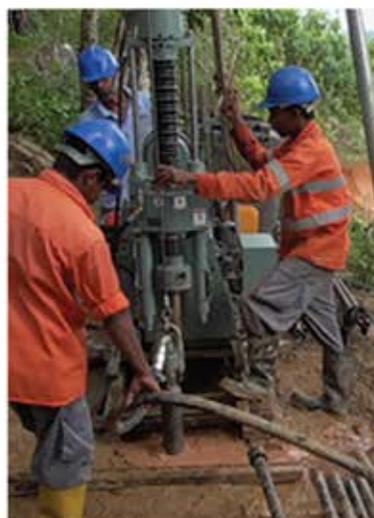
New Rotary Drilling Machine

- Inject Water Pressure Controlling
- Continuous Soil Sampling
- Sampling of Moderately to Highly Weathered Rocks and Fresh Rocks
- Enhanced Recovery and Sample Quality

In particular, the drilling machine equipped with SPT assembly, continuous sampler assembly for soils and coring tools (single-tube, double-tube and double-tube swivel-type) with different grade bit types for rock core sampling acquired through TCLMP has helped NBRO in improving its drilling performance. The double-tube swivel-type core barrel systems, insures borehole stability and good core recovery during drilling and coring. The new machine allows extracting higher quality and continuous soil and rock core samples that enables a clearer and more accurate identification of the geological structure and failure surface(s)

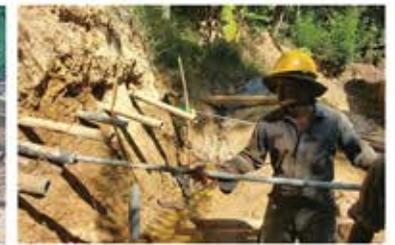
Horizontal drains

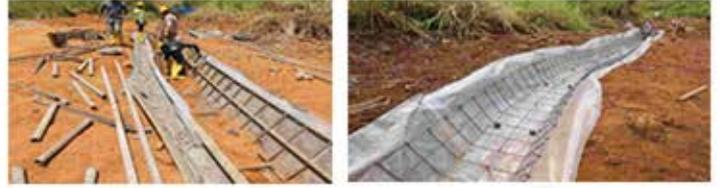
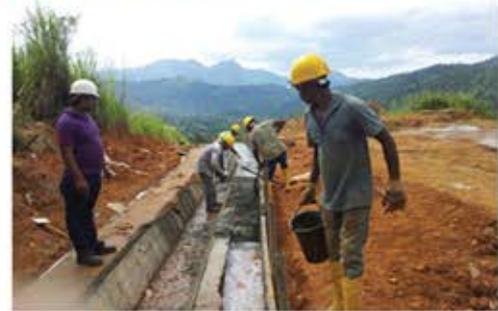
Progress of drainage constructions

Therefore, horizontal borings (gravity drains) and surface drainage ditches were selected as countermeasures to mitigate the landslide. The contract was awarded to ELS Construction (PVT) Ltd for a contract price of 38.9 M. The progress of the drain constructions at Badulusirigama site as at the end of October is 37.7% of the total work.

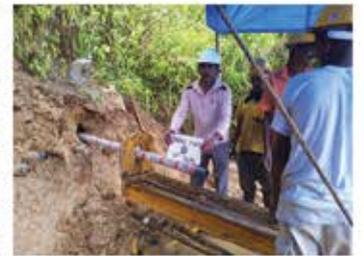
Horizontal drains

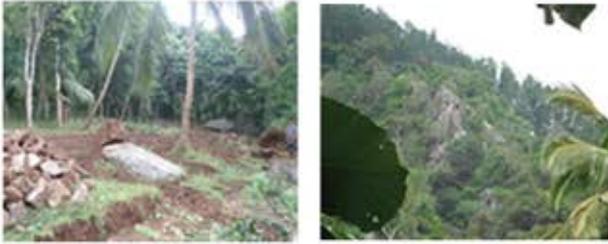
Initial condition of the rock fall site

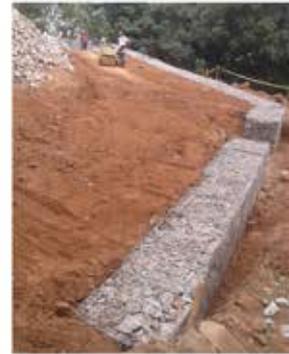
Gabion Wall

Item	Total Quantity	Work done up to 31 st October	Remaining	Total Progress of the work	Remaining Progress of the work
Gabion Work	201 m ³	206 m ³		COMPLETED	
Excavation	450 m ³	1030 m ³	580 m ³	43.70 %	56.30 %
Rock Excavation	412 m ³	210 m ³	202 m ³	51 %	49 %
Rubble Pitching	679 m ²	679 m ²		COMPLETED	
Access Road	100 m	100 m		COMPLETED

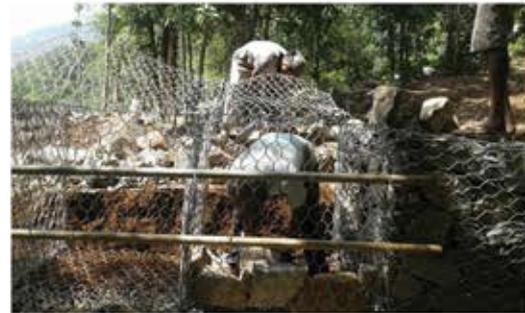
Gabion Wall Construction
