Cultivation of Landslide Disaster Resilience Culture Throø School Environment

Landslide Risk Reduction & Mitigation Division (LRRMD), National Building Research Organisation (NBRO)

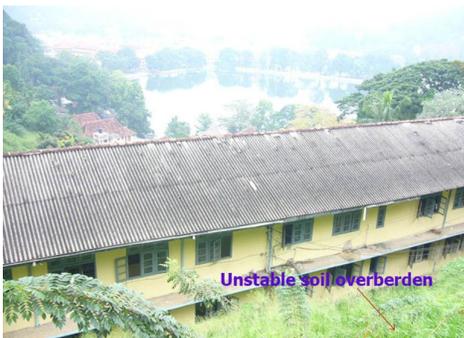
i). Gothami Balika Vidyalaya at the center of Kandy down ó town, does not indicate any natural risk with regard to landslides. On further investigations it was revealed that the school buildings were haphazardly erected and to worsen the situation no proper water drainage system was not installed.

Fig 01- Earth cut collapsed on November 2010 and caused to damaged back side wall of the school building.

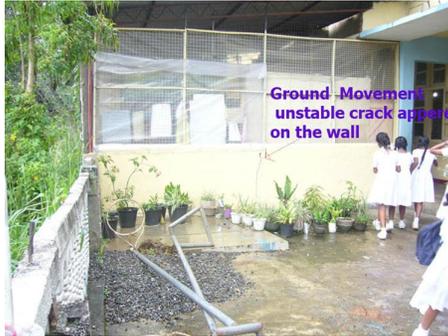
- Often cracks are clearly visible on the wall of the school buildings (see Fig 02).

Fig 02 6 Ground movement warning signal could be identified through the cracks opening on the wall of the school

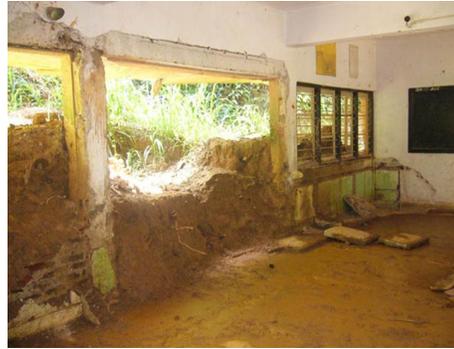
- Collapsing a certain buildings by earth cut and the damage done is clearly visible (see Fig 03) (particularly damage caused to the chemistry lab).
- The large earth masses or lumps going up to heights of 100 feet or above, just behind the school walls. This situation is grave.
- School play ground and the access road is encompassed by large earth blocks (lumps) since 2009, so damaged buildings still lie at the same state and further earth cut are causing danger.

Fig 03 Completely damaged to Chemistry building, caused to collapsed unstable vertical earth cut due to torrential rainy period of Nov.2010

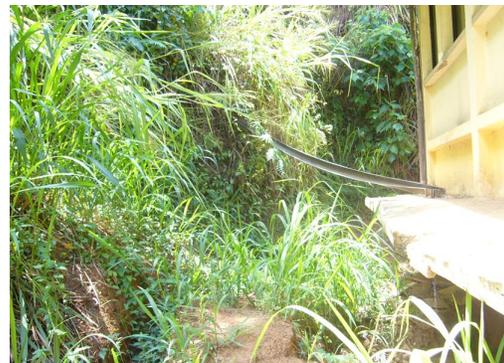
Fig 04- The height of the unstable soil cut still is casing to danger. As shown in period of November 2012.

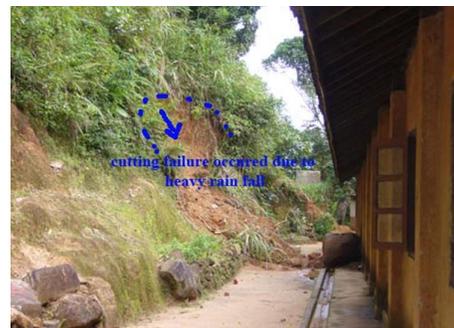
Fig 05- Natural rock and soil masses collapsed and caused to damage wall of the school building period of November 2010.

- The torrential rains in 2009, the earth blocks behind the school building, forced up the school building thus causing damage(see Fig 05).

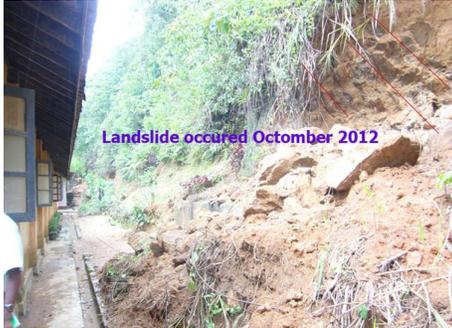
Fig 06- Still natural landslide threat happened at the school premises when the period of November 2012.

- In 2012 rains dislodged and few earth lumps and some rocks, but no substantial harm were done to buildings (see Fig 06).
- The steeply sloped location (scarp slope topography) at the school land does not fit to build a school, and this is not an good Situation.

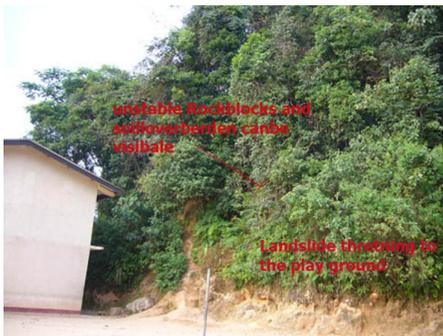
Fig 07- Natural rock fall threatening exposed at behind of the school building and play ground, rock fall was recorded due to the rainy on November 2010.

- In 2010 it has been reported substantially large blocks of rock, earthen masses / lumps falling these causing trouble (see Fig 07).
- Further, Just behind the school ground, large rocks show a potential danger for the school.

- Particularly in the Molagoda Maha Vidiyalaya an early warning system may be developed to warn people about possible rock fall threat. This system can be developed to encompass a wider spectrum.

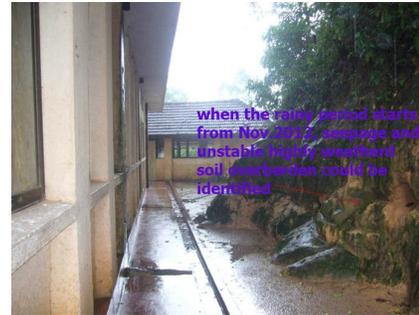
Fig 08 - Unstable ground appearance is increasing and still landslide threat could be clearly visible. Picture taken on rain starts on October 2012.

- Although the buildings were not damaged, large rocks falling may cause life threats to students and other people and also to property.
- Particularly the construction pattern and irregular erection of buildings have aggravated the potential danger.
