# Use of Inclinometer for Landslide Identification with Relevance to Mahawewa Landslide

M.P.N.C. Amarathunga

R.M.S. Bandara

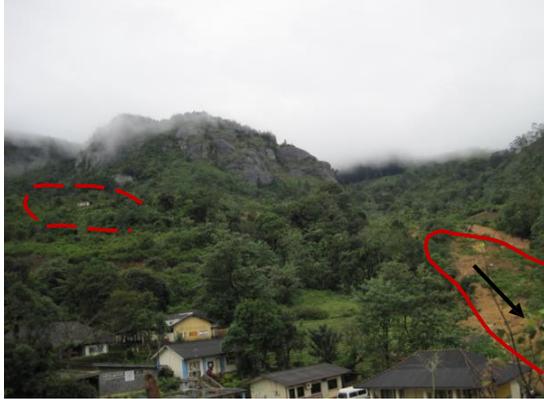
Fig.1 After reactivation of the Mahawewa Landslide in 2011(debri flow and the main scar of the landslide).

The Mahawewa landslide is a massive slope failure that is partial reactivation of ancient landslide in Walapane of Nuwaraeliya District. In January 2007 and February 2011 the landslide was reactivated (Fig 1). Geologically this slope can be categorized as a scarp slope and the whole area is covered with thick colluvial soil layer. The slide length is about 1.5 km and the width is about 250m. There are about 65 families were resettled due to this vulnerability of Mahawewa landslide. Agricultural lands and Irrigation canal systems also damaged by the landslide. Kumbalgamuwa Keerthi Bandara Maha Vidyalaya, the main access road from Walapane to Kandy and the community of the underlying areas are still at a high risk. Preliminary investigation reveals that most of the houses and grounds have developed cracks due to both vertical and horizontal movements (Fig 2). Newly- formed springs and underground flow paths were observed in the main landslide body. This area consists of debris of very old landslide showing evidences of creeping and subsidence in the recent past.

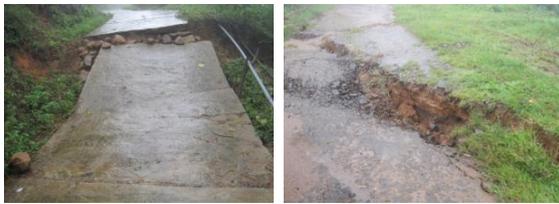
Fig.2 Cracks observed in the head of the landslide.

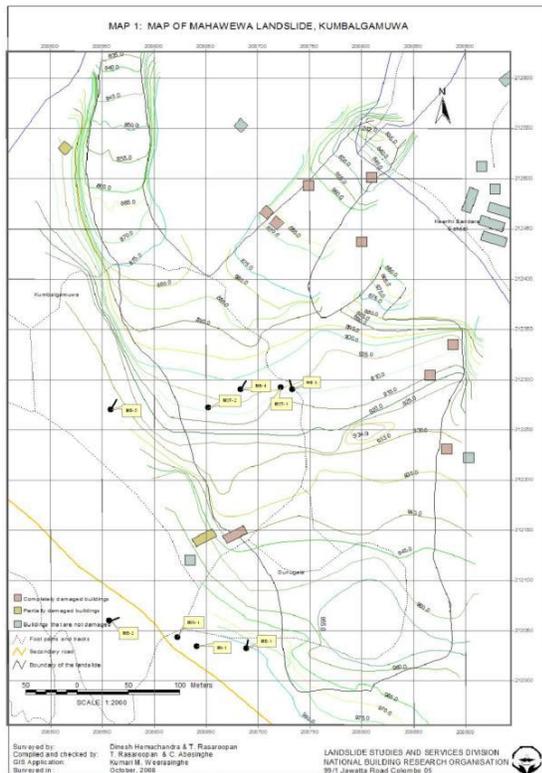
Fig.3 Map of Mahawewa Landslide with Instruments installed locations

with JICA and automatic rain gauges, Strain gauges, extensometers, inclinometer and piezometer were installed in Mahawewa area for monitoring the surface and sub-surface movement to study the controlling characteristics of the landslide.(Fig3) The study mainly deals with the appropriate mitigation measures for Mahawewa Landslide base on the instrumental results, geological and environmental conditions.

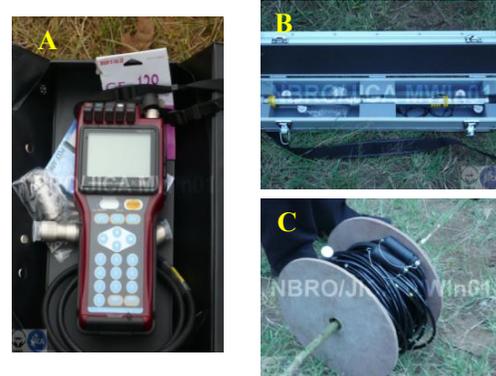
Fig.4 Parts of the Inclinometer. A. Data Logger B. Inclinometer Probe C. Connection Cable

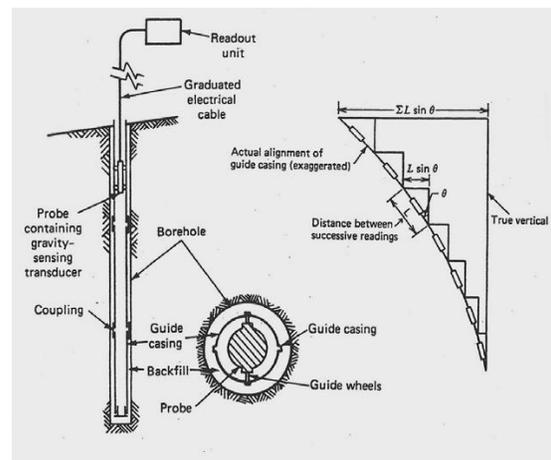
Fig 5a Schematic of Inclinometer probe inserted in casing that is installed to monitor ground deformations

The inclinometer probe does not provide horizontal movement of the casing directly. The probe measures the tilt of the casing which can be converted to a horizontal movement as shown in figure 5a. The deviation from vertical, i.e., horizontal displacement, is determined by the sine function and expressed as follows:

The horizontal displacement profiles of the casing are usually determined using the data from the X- Y axes of the inclinometer casing. These axes are mutually perpendicular vertical planes as shown in Fig. 5a. The X-axis is usually oriented in the direction of slide movement during installation of the casing. Two sets of casing grooves allow the inclinometer probe to be oriented in either of two planes set at 90° to each other (Fig 5b). Thus, horizontal components of movement, both transverse and parallel to any assumed direction of sliding,

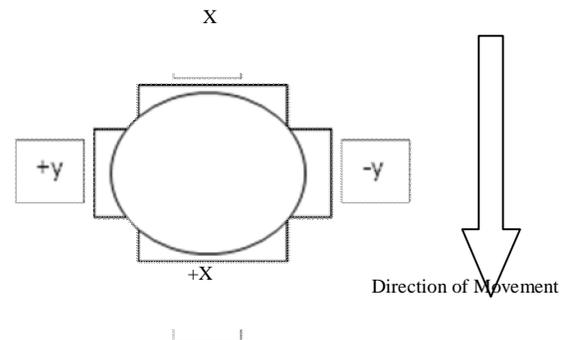
Fig 5b Alignment of X axis to the movement direction

If the X-axis is perfectly aligned with the direction of landslide movement, the entire shear movement will be measured in the X axis and no movement will be detected in the Y-axis. However, it is difficult to determine and align the X-axis in the exact direction of the landslide, especially if the slide is not a single unit. Thus, the actual magnitude and direction of movement are determined by vector summation of the two components of movement measured in the X- and Y-axes. The direction of the X-axis is usually determined using a compass.

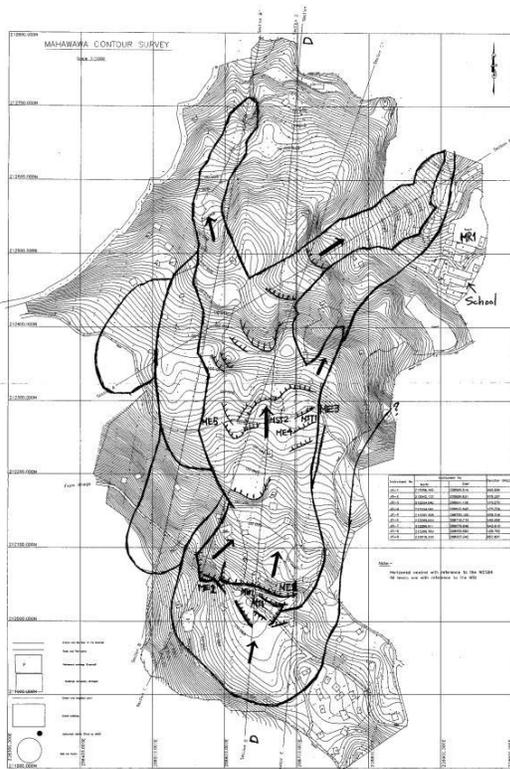
Fig 6 Crack Survey Map of the area.

Topographical Survey shows that most of the area is characterized by large superficial displacements. The rate of displacements is highly variable. The crack survey map shows the ground movement of the area (Fig 6).

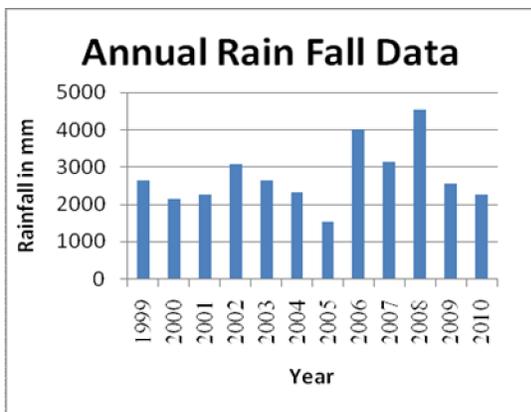
Fig 7 Annual Rainfall Data in Mahawewa Landslide Area

In generally Mahawewa area is influenced by North East monsoon and precipitation of 3300mm/year in average (Fig 7).

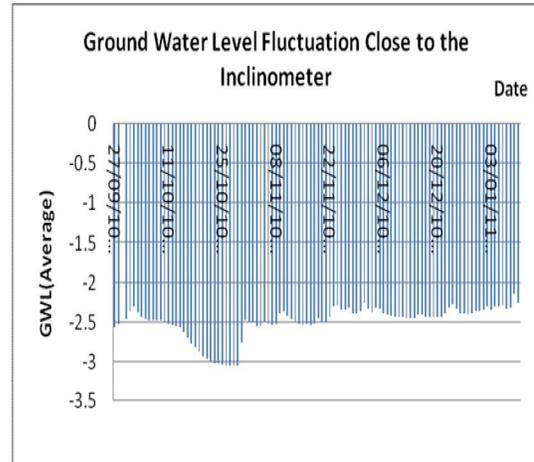
Fig 8a Ground level fluctuation close to the Inclinometer

During the North East monsoon period the groundwater level at the location of inclinometer was increased averagely about 1.5m (fig 8a) and at the strain gauge location it was increased about 6m in average (fig 8b).

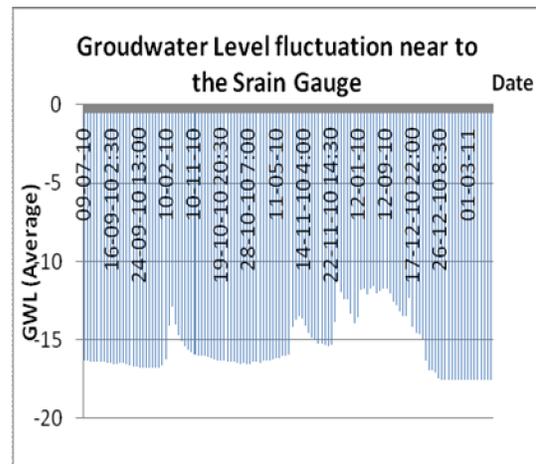
Fig 8b Groundwater Level fluctuation close to the strain Gauge

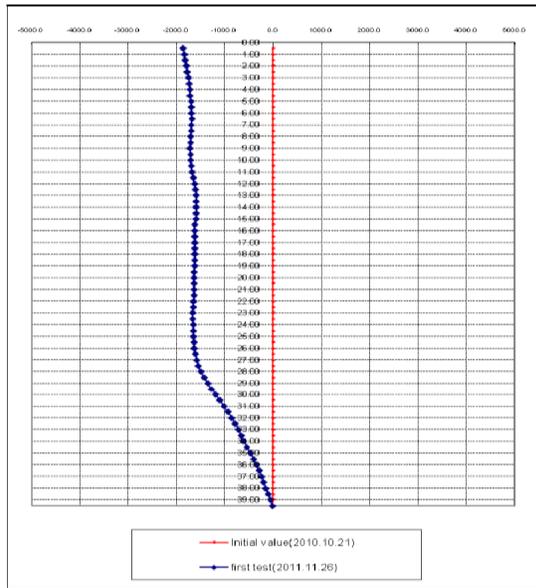
Fig 9 Graph of inclinometer Data of X-X (Displacement in mm vs depth in m) Showed deformation at depths of 13m and 27m.

Inclinometer reveals that slope movements are occurring along different shear surfaces at different depths. According to the graph of the inclinometer data (fig 9), we can find gradual deformation from the bottom (39m) up to 27m. After this movement a big movement were occurred at the depth of 13m during the reactivation of the land slide in January 2011 and then the inclinometer tube was uplifted about 15cm(fig 10).

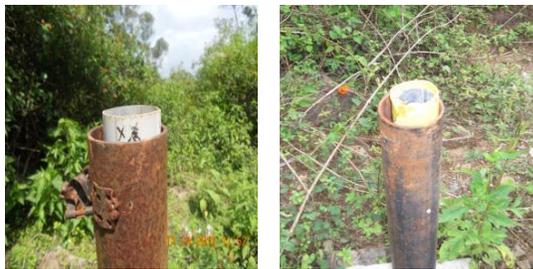
Fig 10 Uplifted inclinometer tube

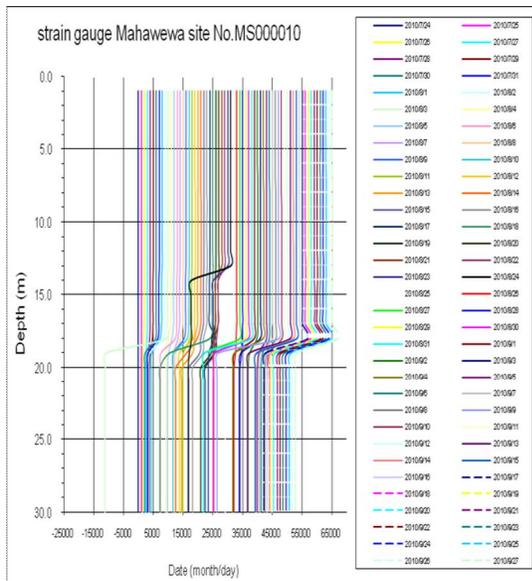
Fig 11 Graph of Strain Guage Data in Mahawewa Landslide

Strain gauge was installed at middle area of the landslide and Analytical data of the strain gauge showed another slip surface at the depth of 19m (fig 11).

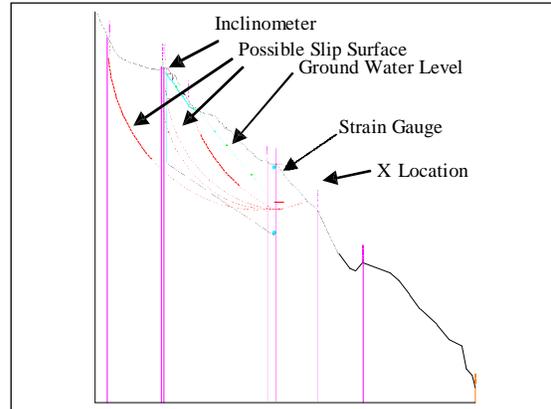
Figure 12 Possible slip surfaces in the slope area according to geological, geomorphological and visual ground crack observations

According to the geological and geomorphologic observation and visual on ground cracks and using analysis data possible slip surface were drawn (fig 12). Main slip surface may be deeper than 39m (beneath the inclinometer end). Debris flow (fig 13) Was occurred at toe of the landslide during reactivation on February 2011 and some ground was subsided about 2.0m on Head of the landslide.

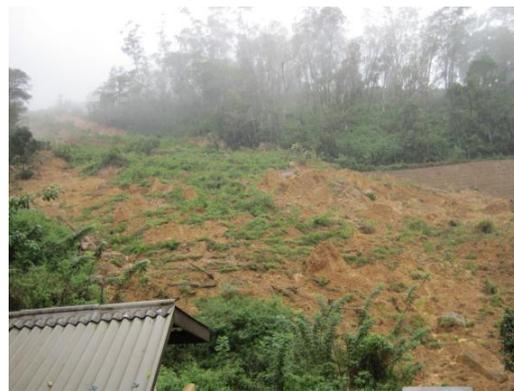
Fig 13 Debris flow which occurred at the toe of the Mahawewa Landslide
