**Site Specific Environmental and Social Management Plan
(SSE & SMP)**

**Site No. 12
Kaluaggala, Colombo District - Package 3**

**Sri Lanka Landslide Mitigation Project
Asia Infrastructure Investment Bank
(AIIB)**

**Environmental Studies and Services Division
National Building Research Organization
99/1, Jawatta Rd
Colombo 05**

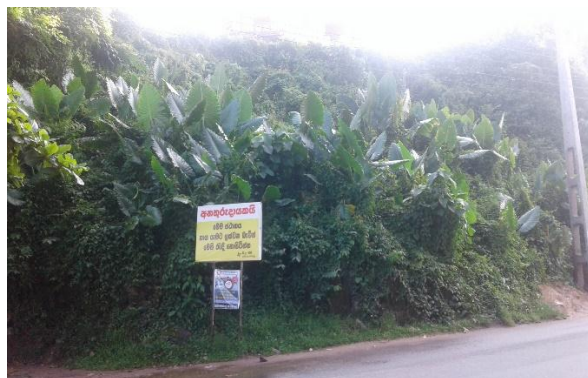
At this location cutting failures have happened several times during rainy seasons. Those failures have extended towards the buildings of the school and church at the crown area of the slope.

Fig 2a: upslope of the slope failure of the Kaluaggala Junction

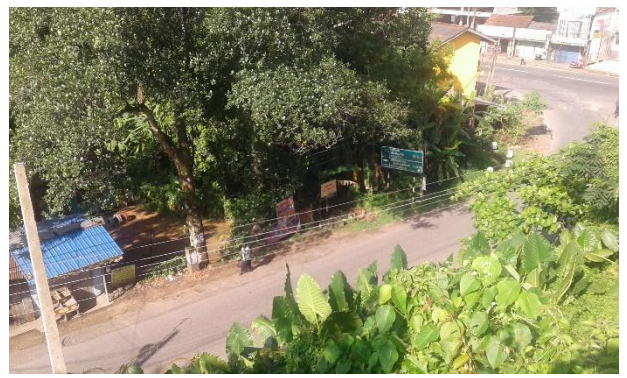
Fig 2b: Downslope view of the slope failure from the school side

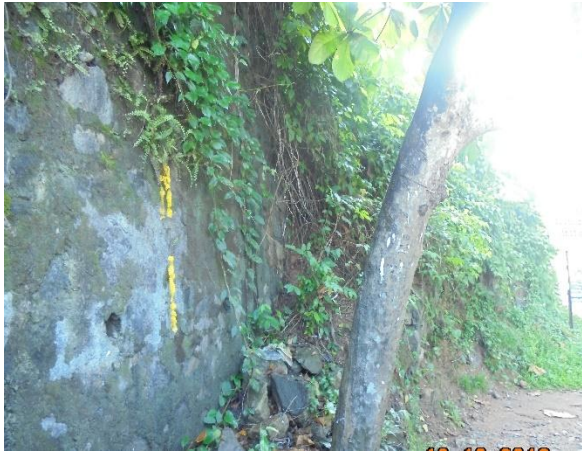
Due to this incident a retaining wall of about 4m height had collapsed. This had damaged the bus halt at the Kaluaggala - Labugama (B188) road near the clock tower. Currently, several cracks have appeared in the remaining parts of the retaining wall. The weep holes of the retaining wall are blocked by soil and the filter layer of the retaining wall is not functional. The mission house of the church which is a historical building built in 1693 was damaged due to the incident. Later the building was removed and new mission house has been constructed.

Fig 2c. Damaged retaining wall at the toe area

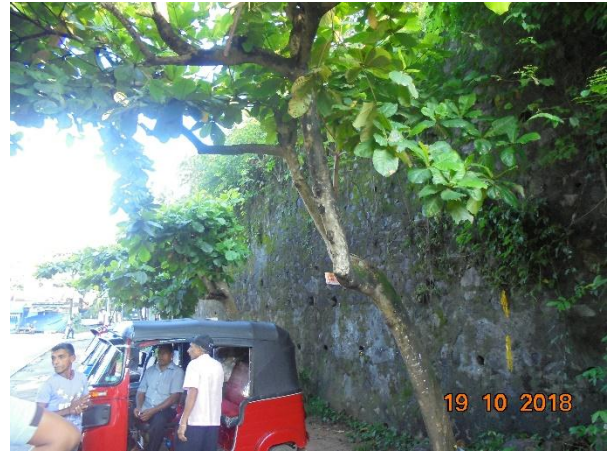
Fig 2d. Three wheel park at the toe area

Immediate to the unstable slope there is a three wheeler park. During rush hours and school times public wait in this location for buses despite the warnings on slope instability risk. The commuters, pedestrians and about nearly 1000 students who are studying the primary section of the school are at very high risk. Devotees and religious functions in the church will be at risk as they are using the roads and transport system to participate in church sermons. The historical statue on crucifixion of Jesus Christ built in 1927 named as "Calvary Statue" on the hill top adjoining the failed slope is at high risk as further failure could damage this statue.

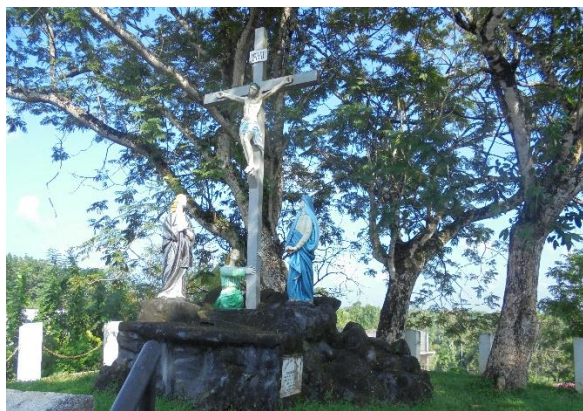
Fig e: Risk culvery statue of the church

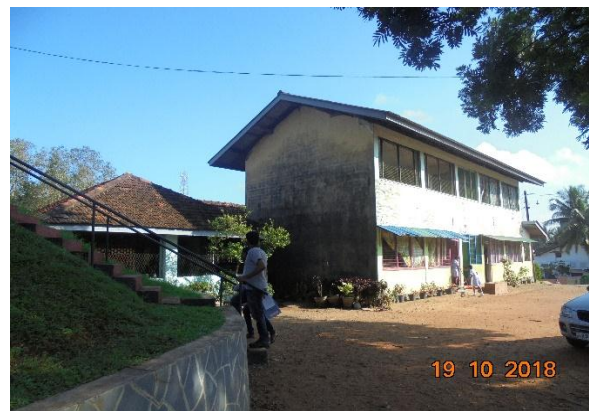
There can be impacts due to high ground vibration (cracks in the buildings) on the buildings and structures on hill top (the statue, school buildings etc)

Fig f: Risk school buildings

exposed more and occupants (Children and Students) will be highly vulnerable to falling risk. Therefore, it is strongly recommend to incorporate protective fencing or wall to prevent people from falling risk.	Very high
<p>x. Low post maintenance and operation designs</p> <p>The mitigation should consider passive techniques such as gravity drains for drainage management. Correct pipe diameters, pore diameters and laying angles should be considered to avoid clogging of drains. Low maintenance structures and designs such as designs to withstand erosive forces, sediment trapping systems etc. should be considered if drain water is expected to be directed to natural streams.</p> <p>The materials used for structures and should be chosen carefully so as to withstand local weather conditions with high durability. Designs should specially consider corrosion prevention techniques if steel structures are used and geotextiles if fine sediments are prone to enter sub drains.</p>	Very high
