**Site Specific Environmental and Social Management Plan
(SSE & SMP)**

**Site No. 06
Kumari Kanda
Kalutara District - Package 8
October 2018**

**Sri Lanka Landslide Mitigation Project
Asia Infrastructure Investment Bank
(AIIB)**

**Environmental Studies and Services Division
National Building Research Organization
99/1, Jawatta Rd
Colombo 05**

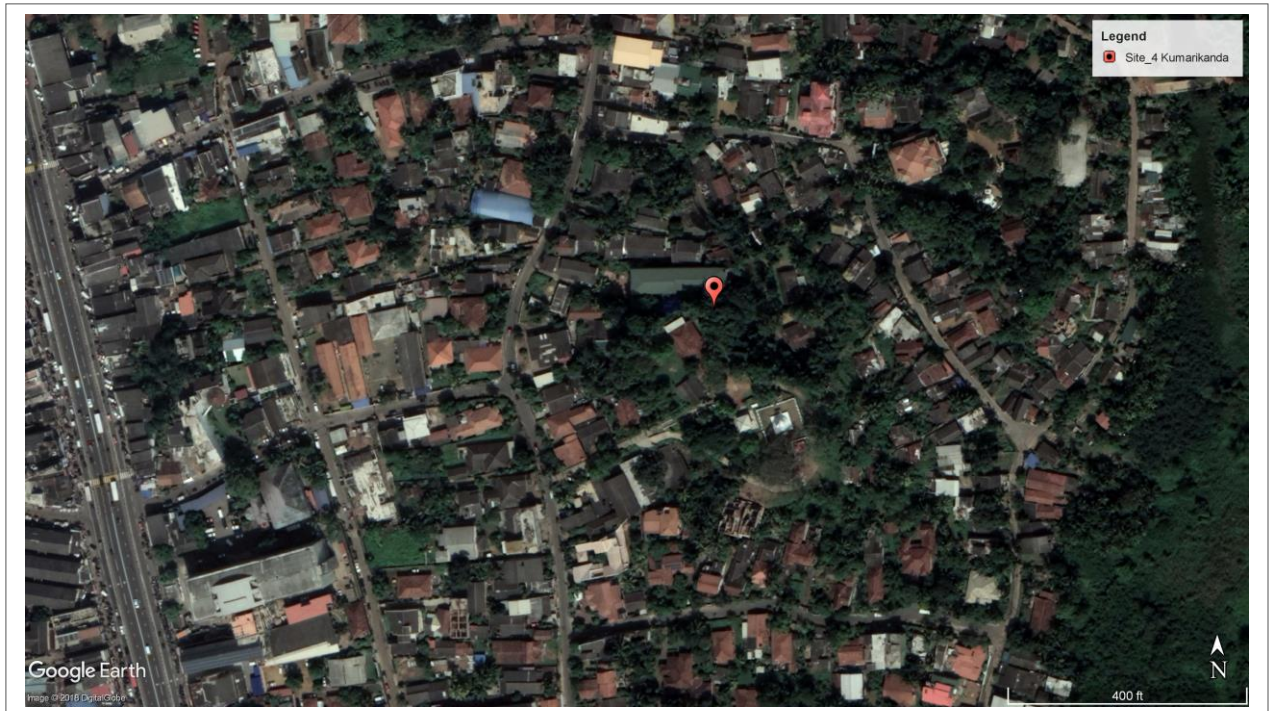
Fig 1: Google image of the proposed landslide mitigation site. Ref. Drone image for details -Annex 1

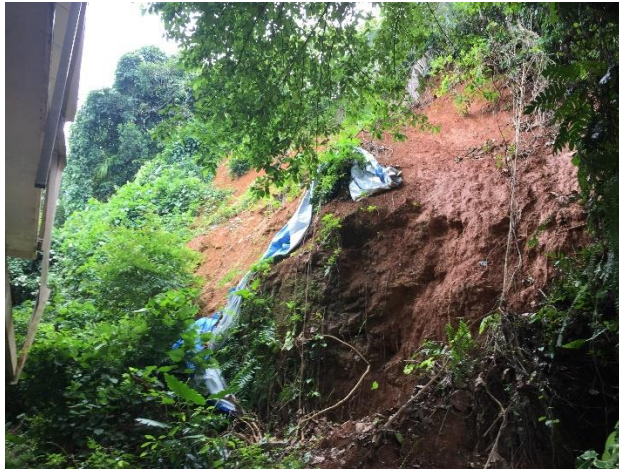
Fig 2a: The failed slope section of the North Western boundary of the Sri Sudharsanaramaya

A cut slope failure had occurred at this location in May 2017 triggered by a heavy precipitation event. This unstable slope cut has been collapsing time to time with the recurring heavy precipitation. The failure had initiated in the hill crest of Kumari Kanda (at the boundary of Sri Sudharshanarma temple on the upslope) resulting falling down of debris to the adjoining district labor office premises in the down slope. The Dislodged debris mass from the failure had deposited in the space between cut slope and the district labor office building.

The main cause of the slope instability is an improper vertical cut. A long vertical cut of about 150m in length had been made along the Southern boundary of the district labor office premises to gain space for building construction of Labour Department. The construction included a retaining wall on a vertical cut while largely disregarding engineered slope stability norms. Removal of toe support together with poor drainage management have made conditions favorable to initiate several cut slope failures while threatening the buildings, and the occupants in both upslope and down slope areas.

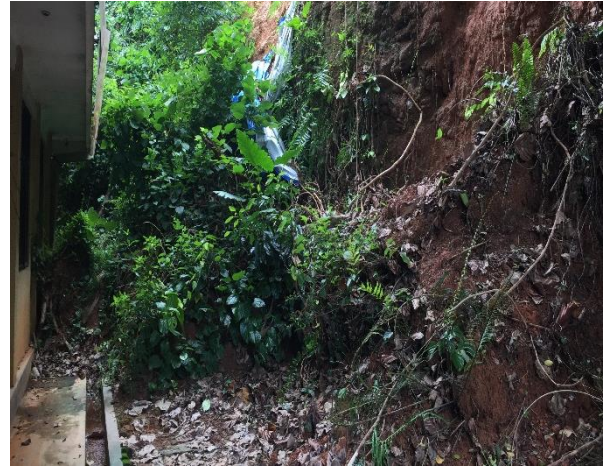
Fig 2b: The passage between the failed slope section and the Labour Department building where debris had deposited due to the incident

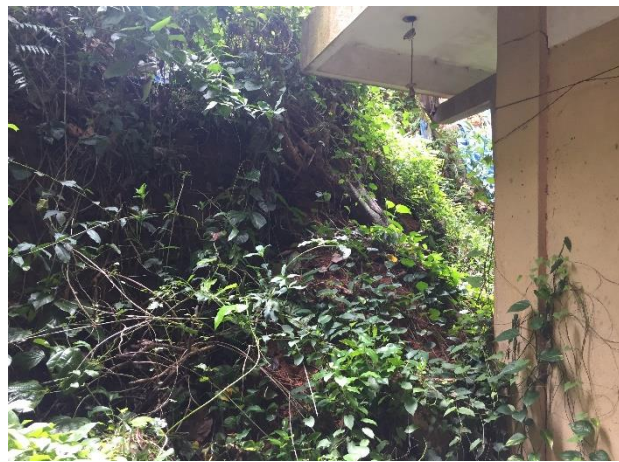
Fig 2c: Collapsed downslope area in the District Labour office

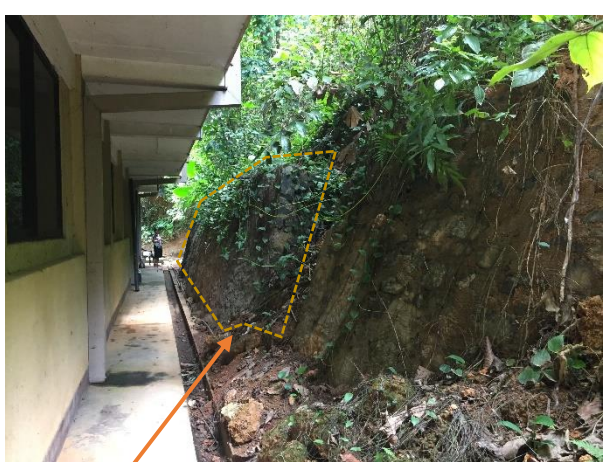
Fig 2d: Partially damaged retaining wall in the toe area

The failures had damaged a part of the retaining wall, but had not caused any damage to the building of the Labor Department in the downslope. During repeated collapses the falling debris obstructed the passage between the vertical cut and the department building. According to the resident priest of Sri Sudarshanaramaya, Ven. Hakmana Thilakasiri thero and the OIC LRRMD - NBRO there is a tension crack on the upslope area and cracks in the hermitage building of the upslope. The incident had damaged a temporary hut located in the vicinity of the failed section on the upslope area but no casualties due to the incident.

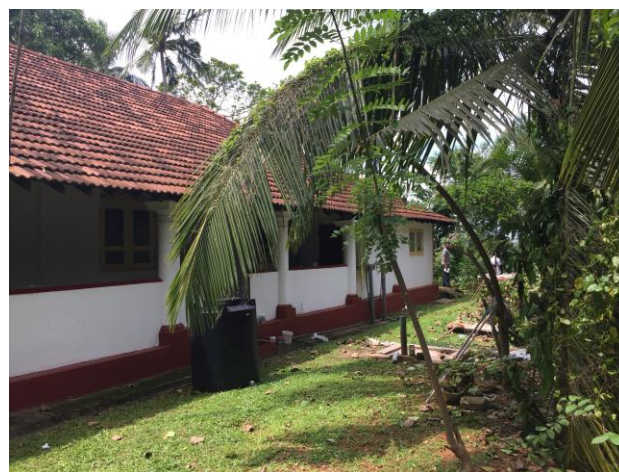
Fig 2e: Hermitage of the Sudharshanaramaya at risk (upslope)

In addition, Sri Sudharshanarmaya temple at Kumarikanda which is an important historical Buddhist temple in the upslope area too is graded under high risk category. Tension crack in the temple premises poses high risk to the religious structures, events and the buildings of the temple. The damage to structures may result temple premises unsuitable to future religious activities and will impact on important religious concerns of local residents who are devotees of the temple. Further, the passage between the Labour Department building and the failed slope is commonly used by the visitors to access sanitary facilities. The failure may obstruct this passage, and in case of a sudden failure it can even result casualties.

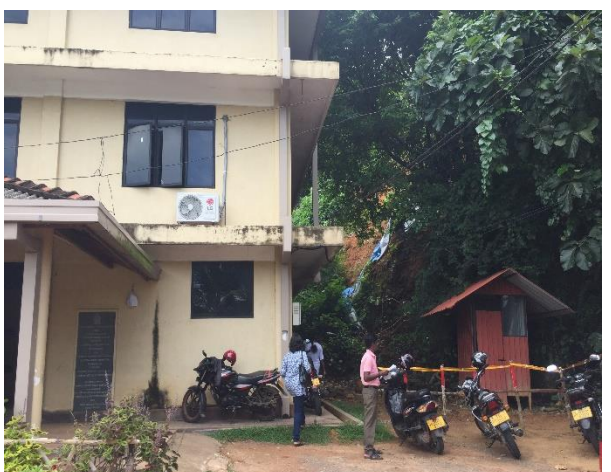
Fig 2f: District Labor Office building at risk (downslope)

Currently, the failed slope adjoining the district labour office and the temple are highly unstable and is subjected to erosion. According to NBRO investigations a tension crack and unstable sections on the slope pose future risk of failure risking people and functions of district labor office building in down slope area.
