**Site Specific Environmental and Social Management Plan
(SSE & SMP)**

**Site No.07
Polgahawela Bus stand, Kurunegala District - Package 4
October 2018**

**Sri Lanka Landslide Mitigation Project
Asia Infrastructure Investment Bank
(AIIB)**

**Environmental Studies and Services Division
National Building Research Organization
99/1, Jawatta Rd
Colombo 05**

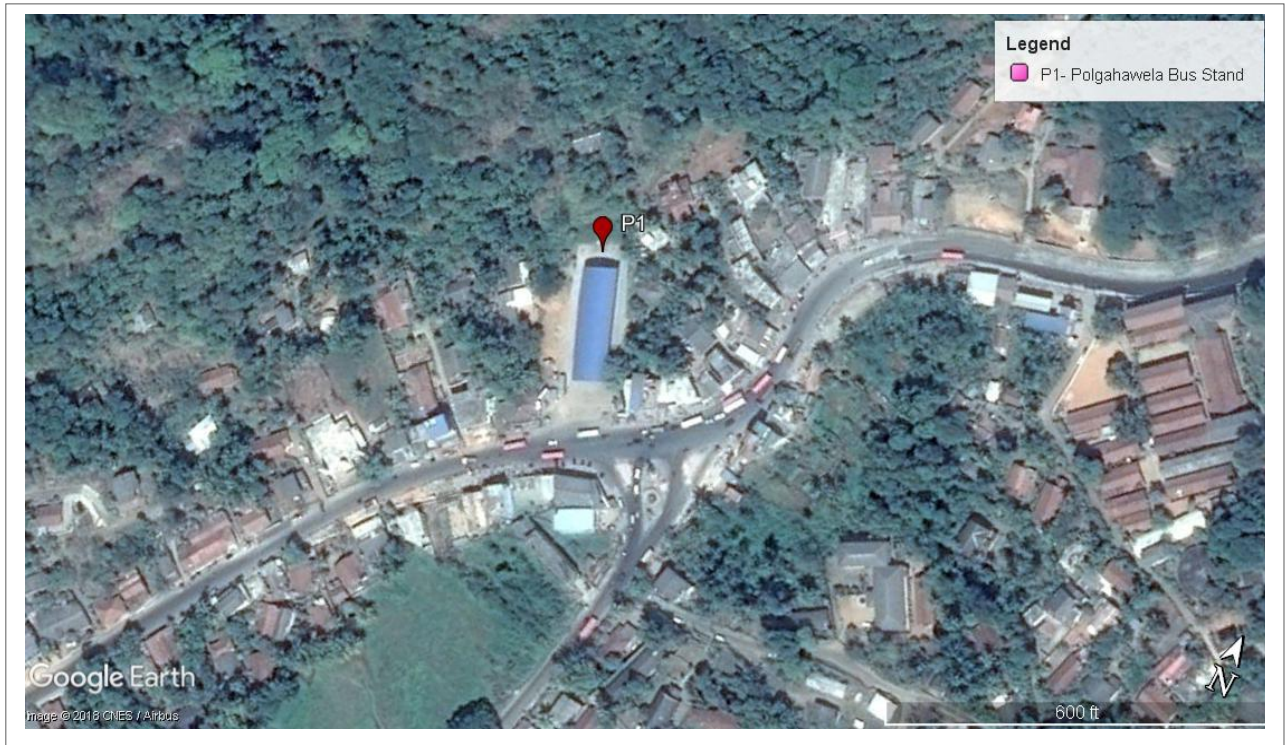
Fig 1: Google image of the proposed land slide mitigation site and surrounding environmental features and service infrastructure.

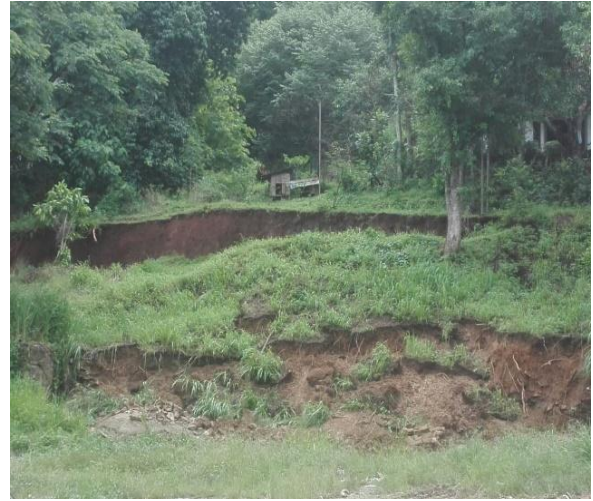
A cut slope with a concrete retaining wall at the rear boundary of the Polgahawela Bus Stand had subjected to sudden collapse in May 2018. The slope had been cut and reinforced with a retaining cum a surface drain system in 1980's. A section of the slope together with the part of the retaining wall had collapsed following a heavy precipitate in May 2018. There is a house with occupants on upslope who were asked for immediate evacuation after the incident. The occupants later returned to original place, but they are vigilant on future slope movement and on heavy rainfall events.

Fig 2b: Slope failure at the rear boundary of bus stand

The proposed mitigation works will be largely concentrated on slope modification, improvement to the drainage and retaining structures. Which will include permanent structures to convey the runoff through proper drainage management and directing the runoff to nearby culvert by a surface drain system. Lowering the water table in the unstable seepage area by insertion of horizontal drainage systems coupled with vertical drainage wells will also include into subsurface drainage systems. Reinforcing the weak embankments and etc. will also be considered to strengthen the stability of the slope.

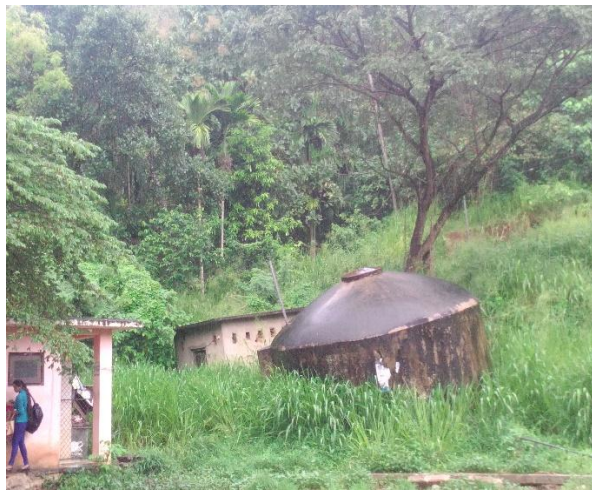
Due to the slope failure no houses were damaged. A water tank which made for the supply of water to houses at upslope area had been damaged due to the slope failure. There is another small building which is also damaged. The incident has no casualties, and no significant crop/ agricultural lands damaged due to incident.

Fig 2c: Damaged water tank and building behind the water tank

The water supply tank damage, toppled is not used to supply water. Hence has no impact. There are no impacts on sewage, electricity lines also.

- ii. There is a water supply lines and a water tank and building unit already damaged by the slope failure in the proposed mitigation area. These may require to be removed. These will be removed with concurrence of Polgahawela Pradeshiya Sabha.

The water tank even if damaged should not be removed without full approval from the Polgahawela Pradeshiya Sabha. They may consider removal of the structure at the project cost as it has no future value. But, signing a legally bound agreement between the property owner and the project implementing authority allowing no-objection to remove the structures is mandatory.

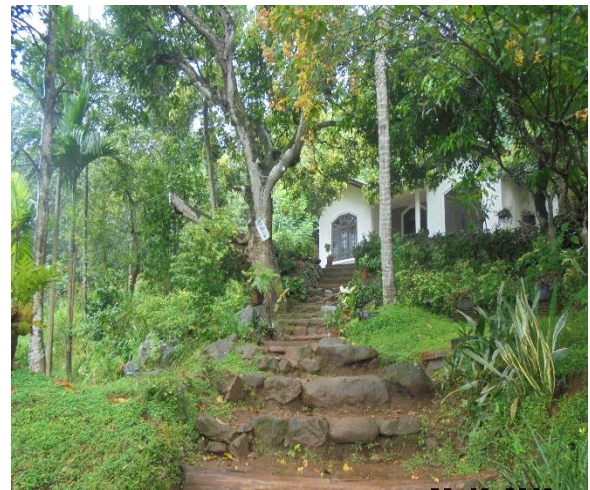
Fig 2d: Risk house at upslope area

After the incident the deformed slope geometry, the loosen soils and tension crack on the crown area have created favourable conditions for high ingress of water to make slope highly susceptible to a future failure. As no any remediation measurers have been done to improve the slope stability, the slope will experience minor to large scale failures at recurring extreme precipitations making the upslope area and immediate downslope highly unsafe for bus stand users, commuters and the families still living in the upslope area

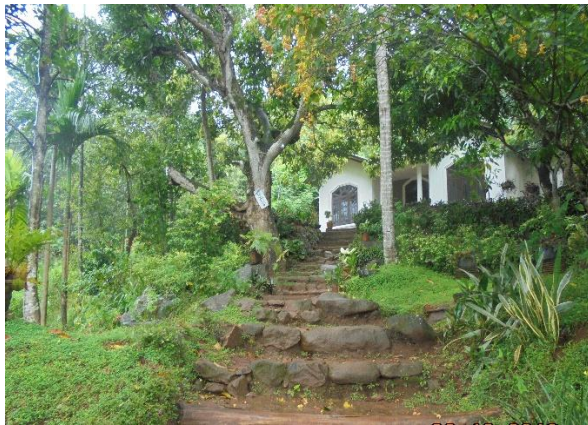
Fig c: High Risk house– Mr Thuwan Dilshad’s house

May be triggered if project based cracks occur in the houses. The project should have an arrangement to pay compensation to the affected parties based on a technical evaluation report.

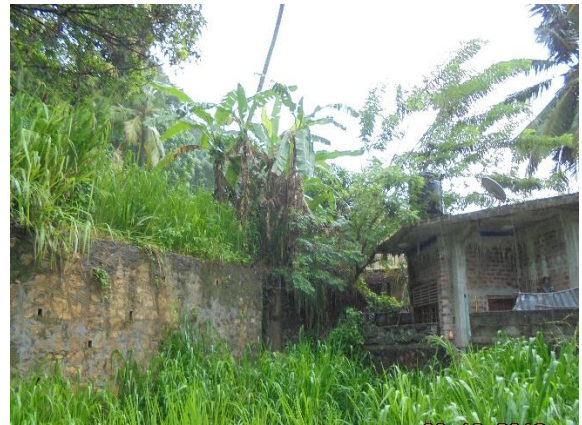
Fig d: Unstable retaining wall (Constructed in 1982)

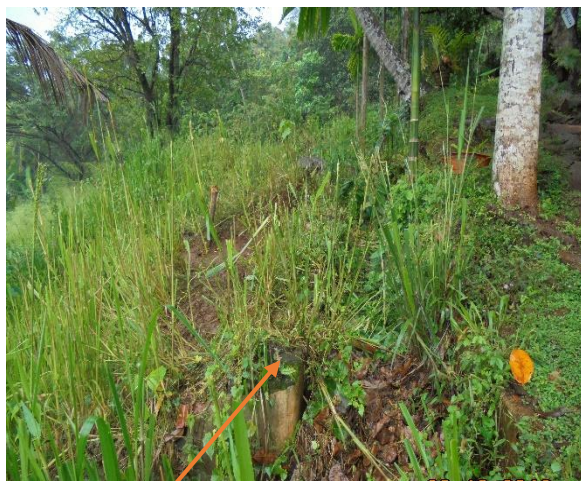
Unmanaged land use can be seen at the sloppy area. A surface drainage system had been developed during the bus stand construction. However, poor drainage management (drainage filled with soil) is linked to the slope failure. Present land uses in the downslope of the moving slope is largely urban settlements and home gardens with few trees. Home gardens with a houses are found in the upper slope area and right hand side of the slope.

Fig e : Existing drainage system filled with mud and debris(Constructed in 1982)

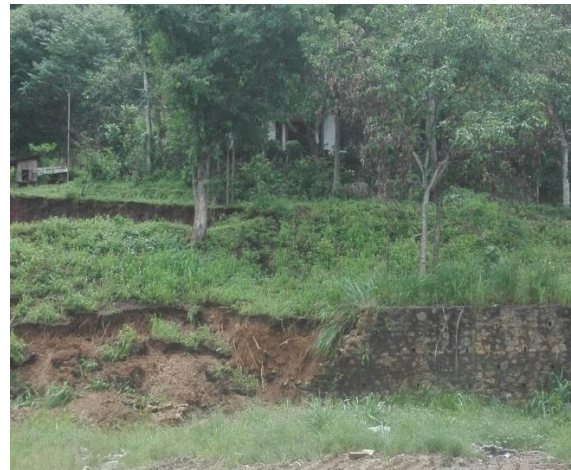
Fig f: Damaged retaining wall
