GEOTECHNICAL ASSESSMENT ON THE FAILURE AT MEETHOTAMULLA WASTE FILL

May, 2017

National Building Research Organisation

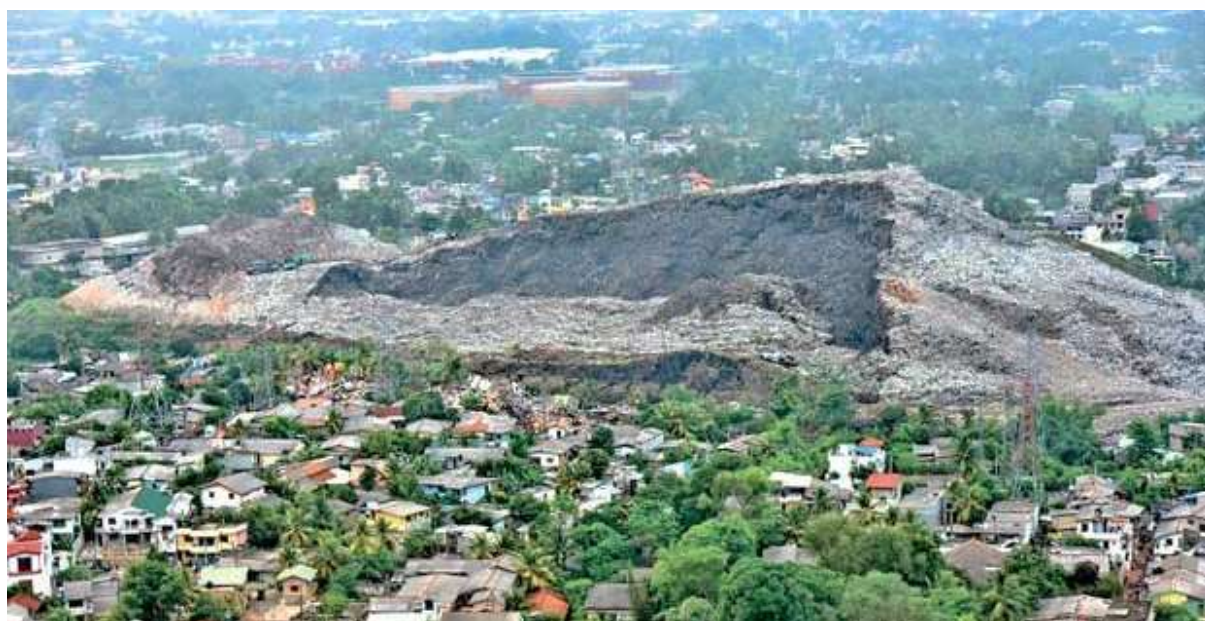
Figure 1: Aerial image indicating the failure face of the waste fill

According to the eye witnesses the collapse had taken place initially as a progressive failure followed by an accelerated movement and then it had come rest while smashing a section of South Western (SW) toe area. At the time of investigations there were no notable movements of waste or ground.

Soon after the incident, a series of cracks oriented perpendicular to the axis was clearly observed within the subsided segment of the waste fill. But, no cracks could be observed at the crest of the waste fill soon after the incident. Through the site inspection, it was revealed that several uneven cracks, slumps, inverted earth blocks etc. existed within the upheaved zone. No significant cracks were observed entirely over the other segments of the waste mound.

The observation soon after the failure revealed that there was seepage of water from the failure surface. Also, the lower portions of the exposed section of the waste fill appeared wet after the collapse and at this time the water table was observed to be as closer to the ground level.

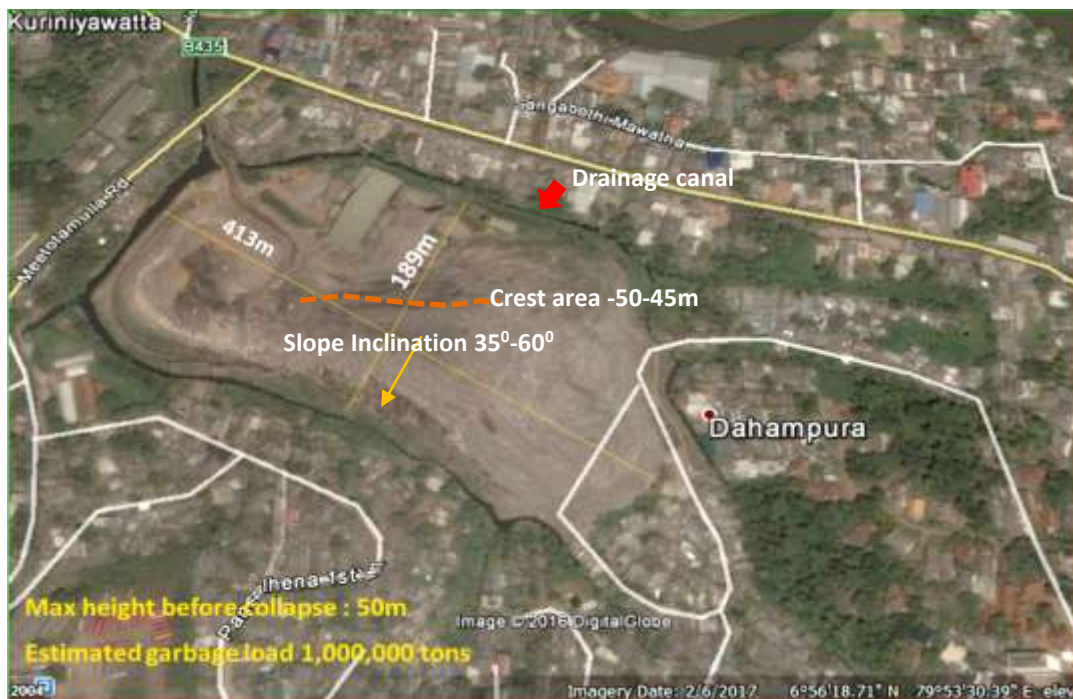
Figure 4: Spatial details of the Municipal solid waste dump in February 2017 before the collapse: Source: Google earth

Drone survey was conducted in the area to study the physical geometry, and to obtain spatial data and cross sections of the waste dump. The spatial data obtained from the drone survey shows that at the time of collapse, the dump has occupied an area of 78000 m², having a maximum length of approx. 413m in the NW to SE direction and a approx. width of 189 m in NE and SW direction. The maximum crest height of the mound was in the range of 45- 50m. At this height, the garbage placement has made a ridge like shape in the NW to SE direction, and its slope inclination towards SW direction was in a range of 35⁰-60⁰ (**Figure 4**). Compared to the failed segment of the waste fill, the rest of the segments are low in height and inclination.

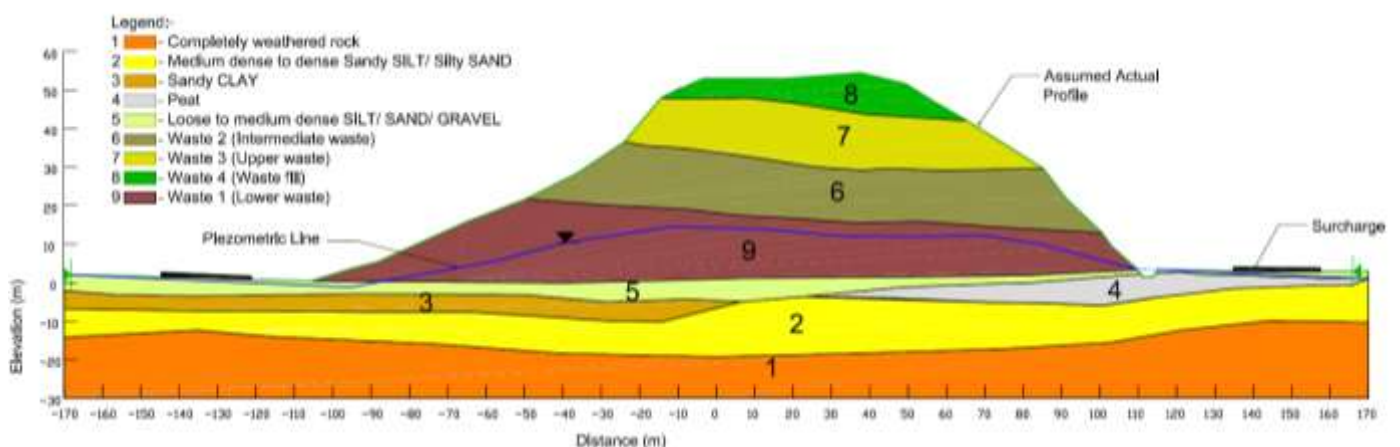
The assumed full cross section across the waste fill together with the subsoil profile and waste profile is shown in **Figure 7**.

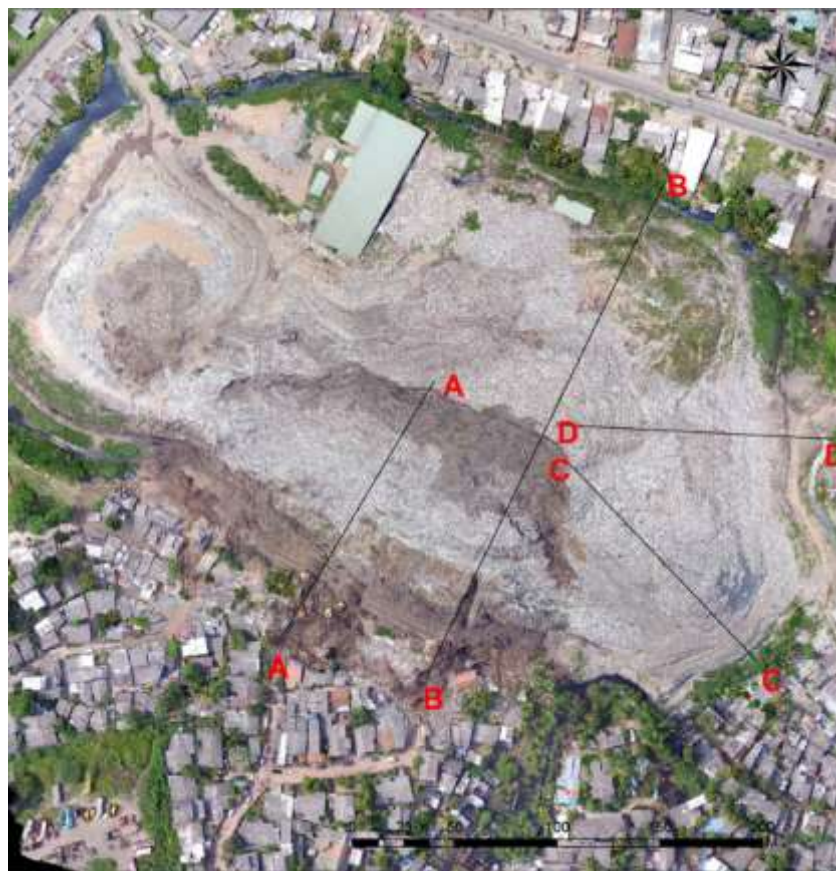
Figure 8: Map showing the selected sections considered for Stability Analysis

Figure 8 shows the topography of the failure site generated from the drone images. The stability along 04 different cross sections were modelled covering all the critical areas of the waste fill site (**Figure 9**). The most suitable profiles for the different cross sections of the waste fill were developed based on the visual observations and the expert judgment. The profiles generated for different cross sections are shown in the **Annexure-2** with the results of the model analysis.
