# **GEOTECHNICAL ASSESSMENT ON THE FAILURE AT MEETHOTAMULLA WASTE FILL**

**May, 2017**

**National Building Research Organisation**

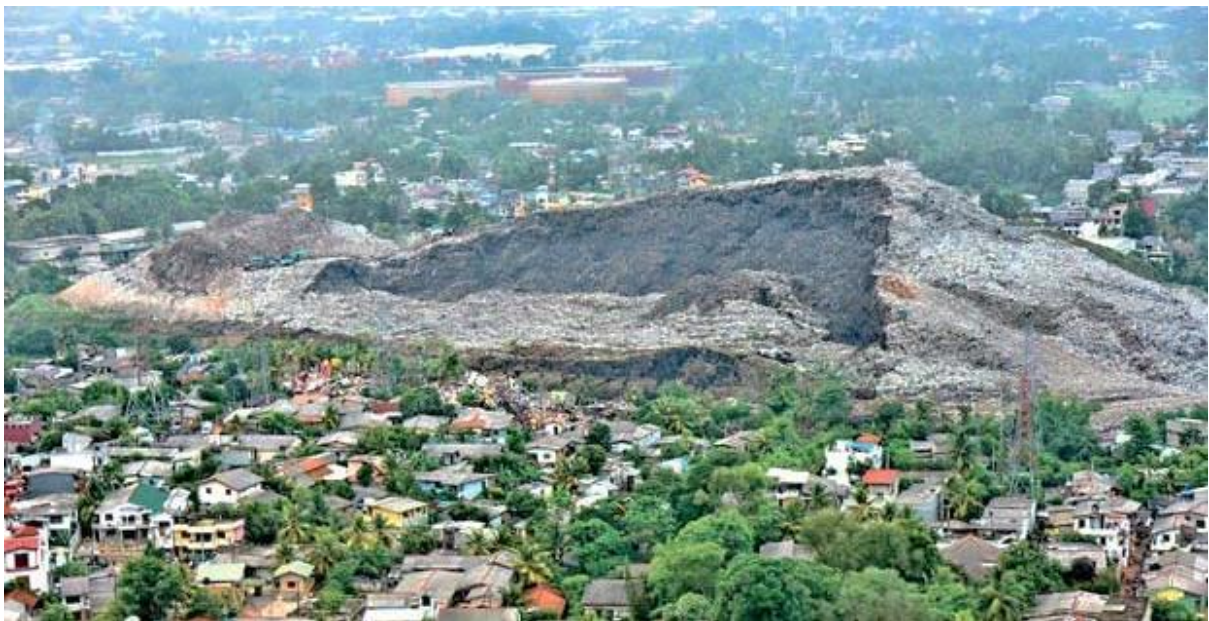
*Figure 1: Aerial image indicating the failure face of the waste fill*

According to the eye witnesses the collapse had taken place initially as a progressive failure followed by an accelerated movement and then it had come rest while smashing a section of South Western (SW) toe area. At the time of investigations there were no notable movements of waste or ground.

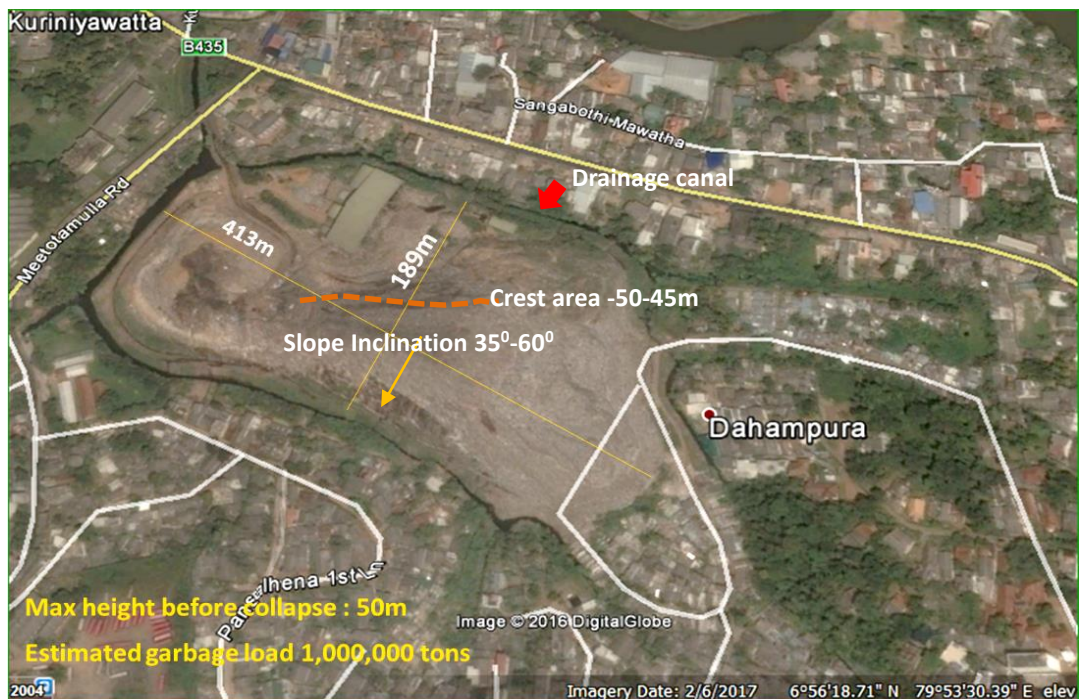
Drone survey was conducted in the area to study the physical geometry, and to obtain spatial data and cross sections of the waste dump. The spatial data obtained from the drone survey shows that at the time of collapse, the dump has occupied an area of 78000 m<sup>2</sup>, having a maximum length of approx. 413m in the NW to SE direction and a approx. width of 189 m in NE and SW direction. The maximum crest height of the mound was in the range of 45- 50m. At this height, the garbage placement has made a ridge like shape in the NW to SE direction, and its slope inclination towards SW direction was in a range of 35<sup>0</sup>-60<sup>0</sup> (**Figure 4**). Compared to the failed segment of the waste fill, the rest of the segments are low in height and inclination.

Figure 4: Spatial details of the Municipal solid waste dump in February 2017 before the collapse: Source: Google earth

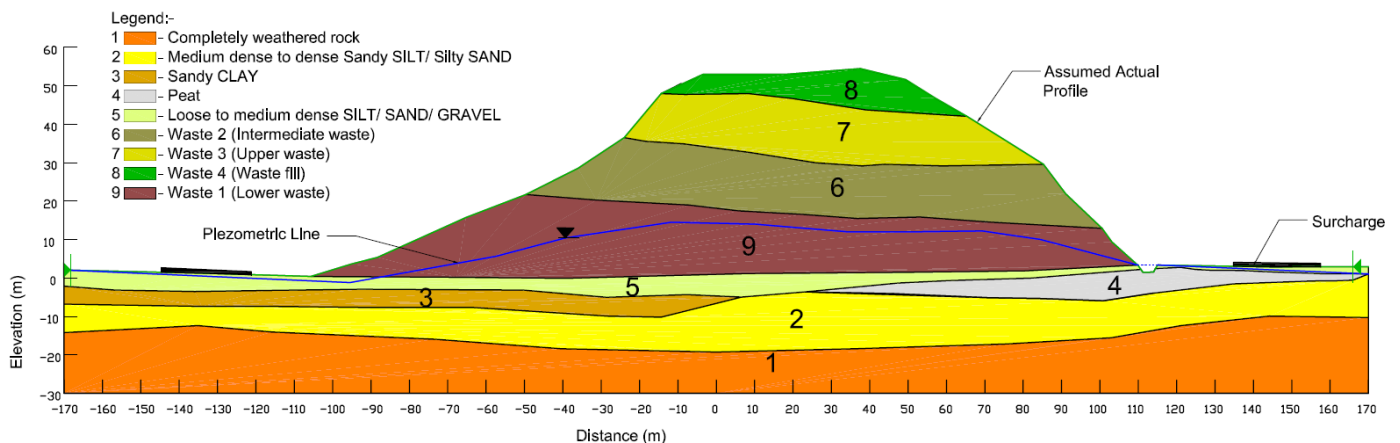
The assumed full cross section across the waste fill together with the subsoil profile and waste profile is shown in **Figure 7**.

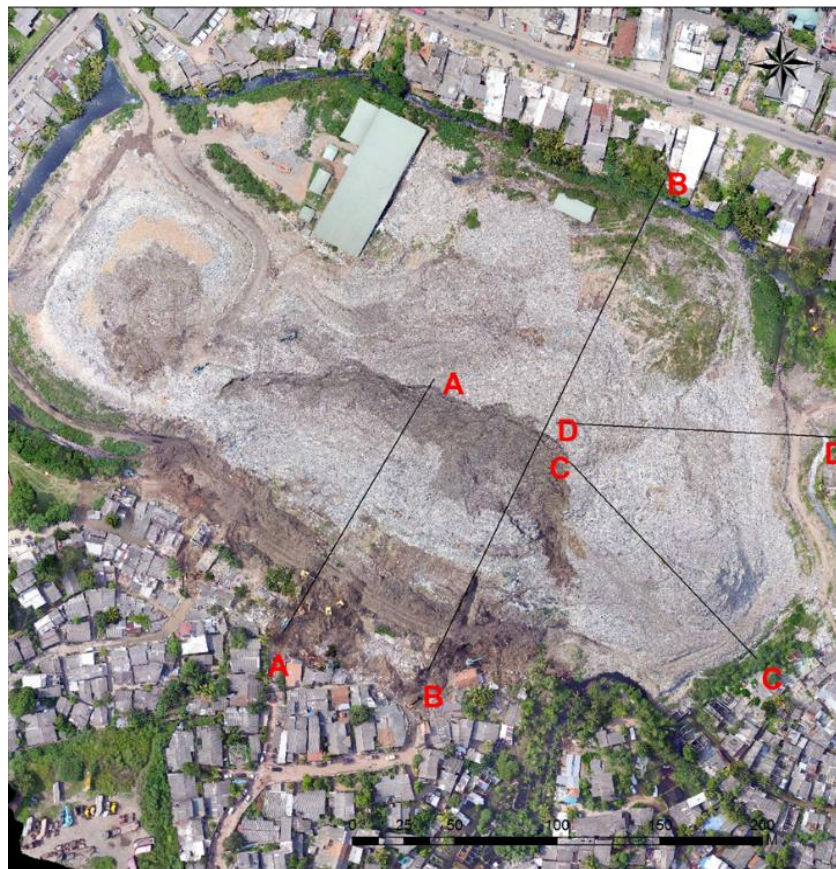
**Figure 8** shows the topography of the failure site generated from the drone images. The stability along 04 different cross sections were modelled covering all the critical areas of the waste fill site (**Figure 9**). The most suitable profiles for the different cross sections of the waste fill were developed based on the visual observations and the expert judgment. The profiles generated for different cross sections are shown in the **Annexure-2** with the results of the model analysis.

*Figure 8: Map showing the selected sections considered for Stability Analysis*

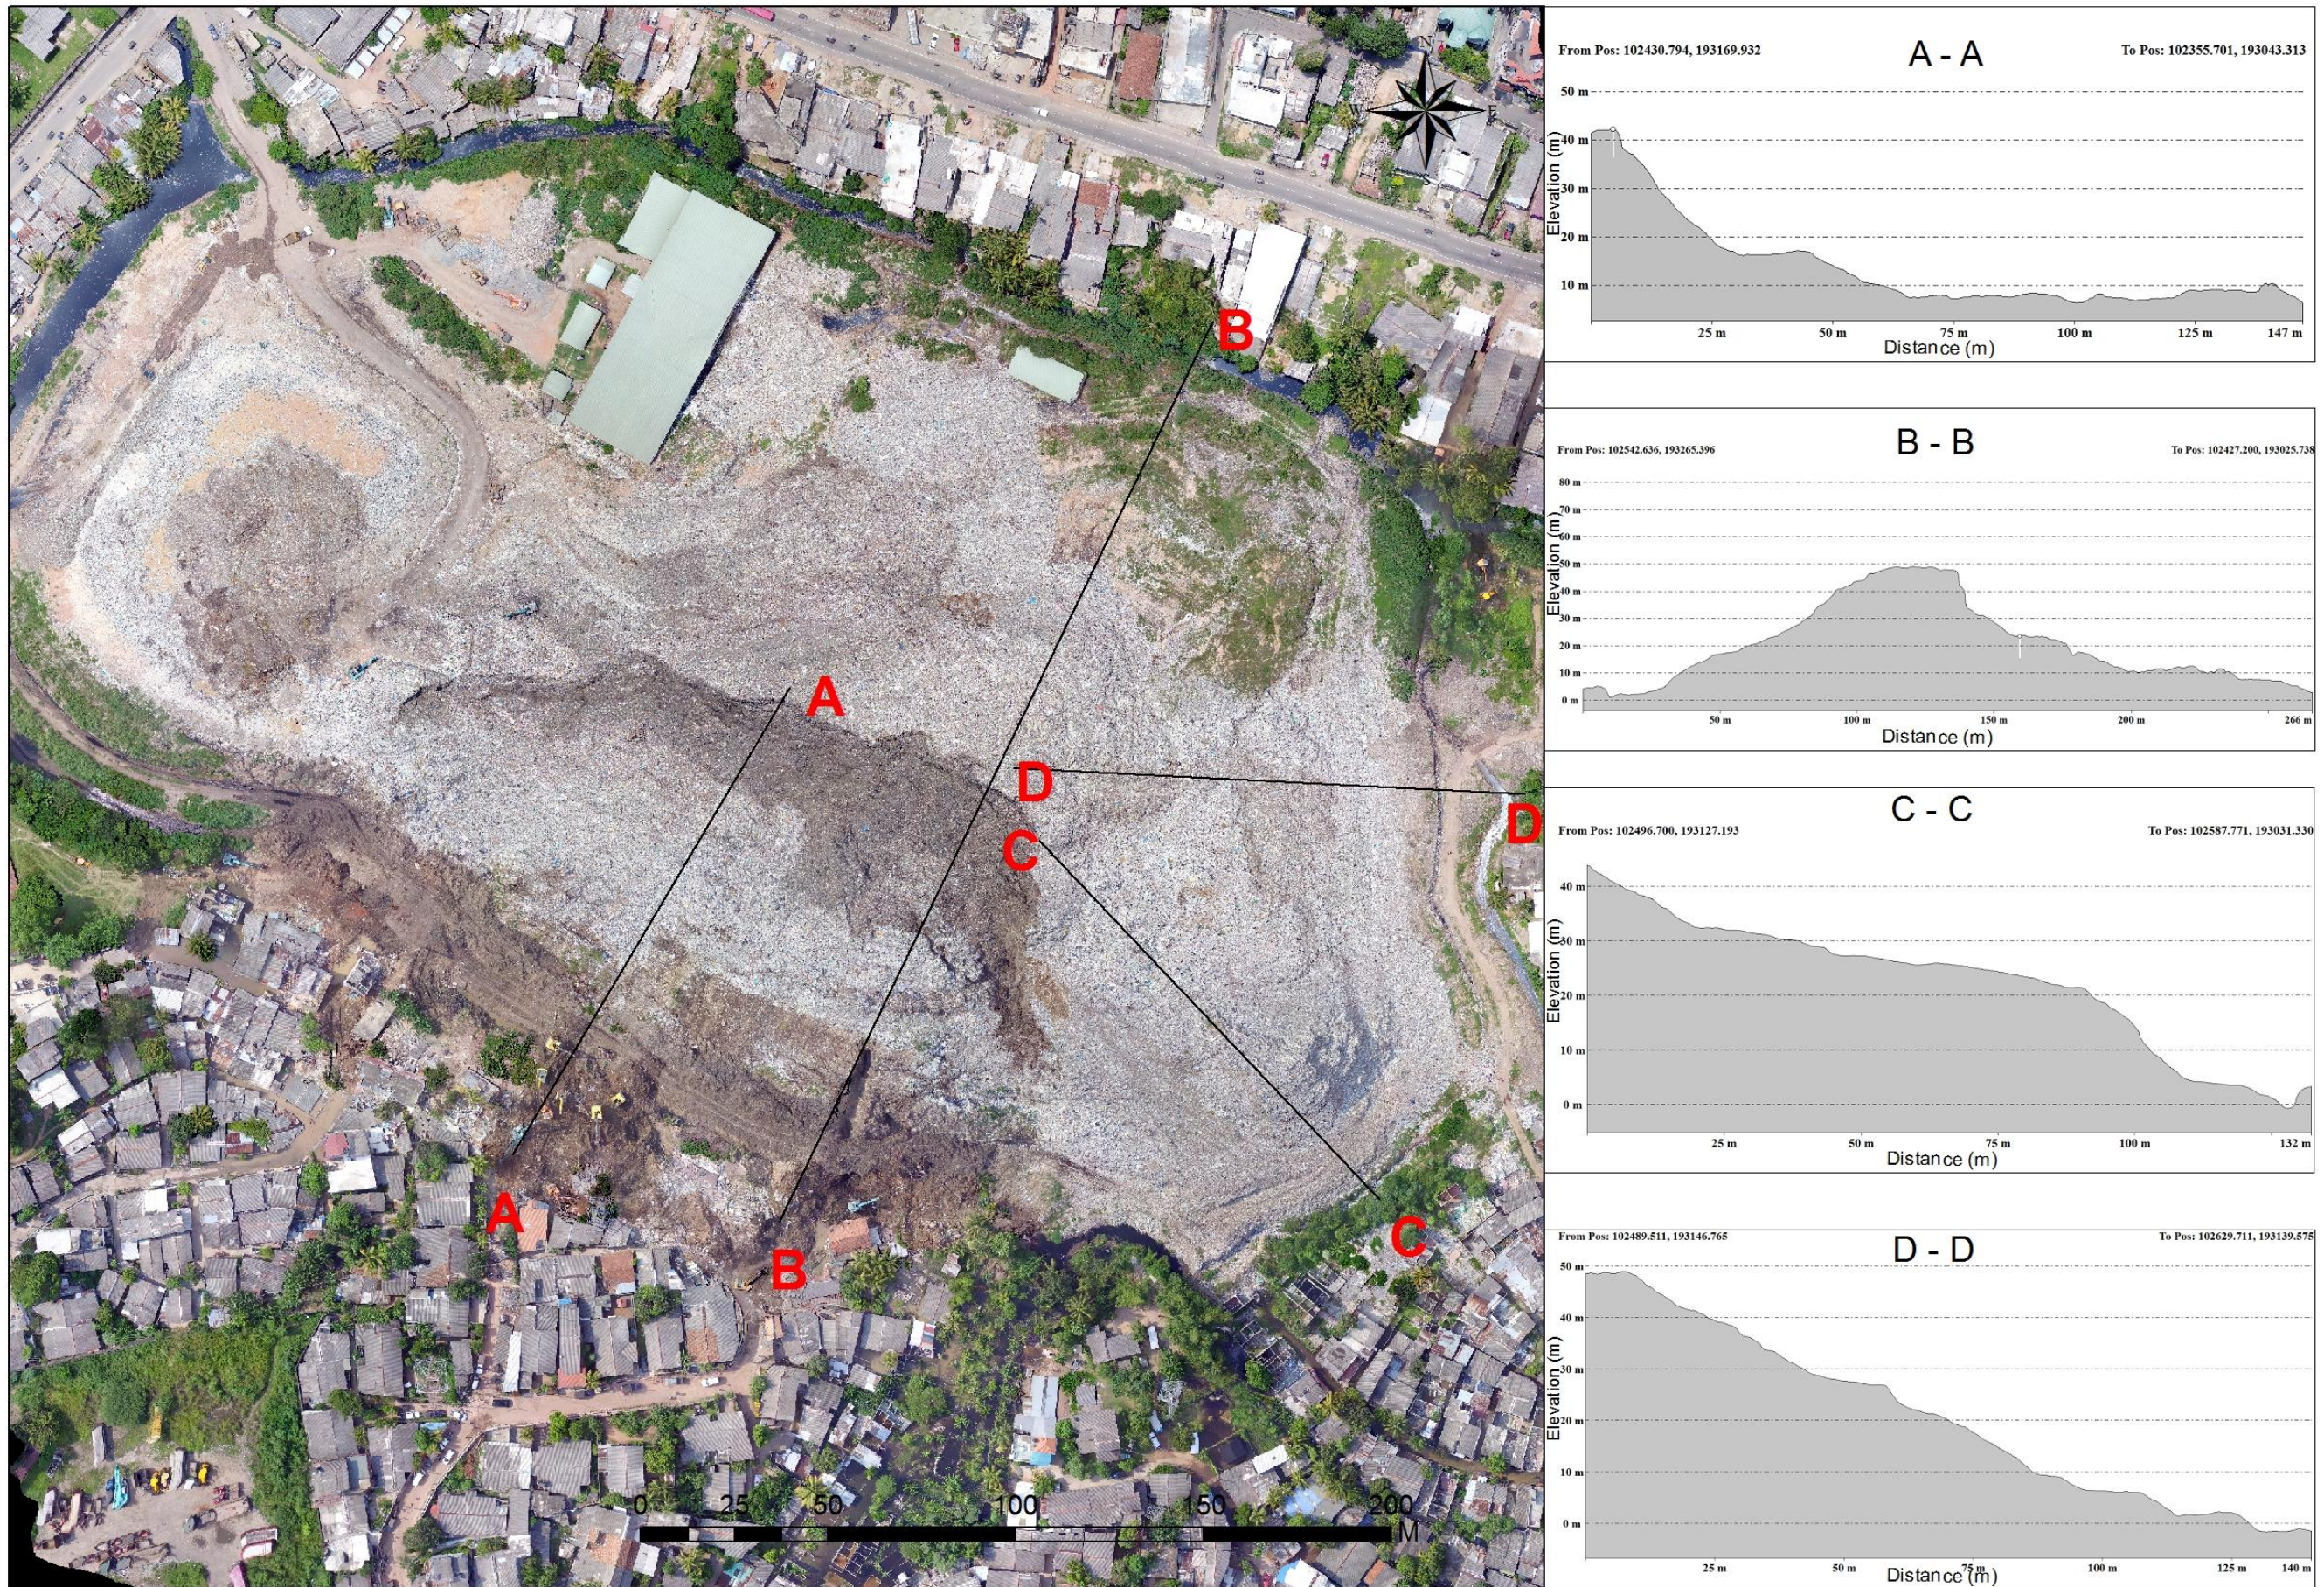
Figure 9: Cross sections selected for the stability analysis

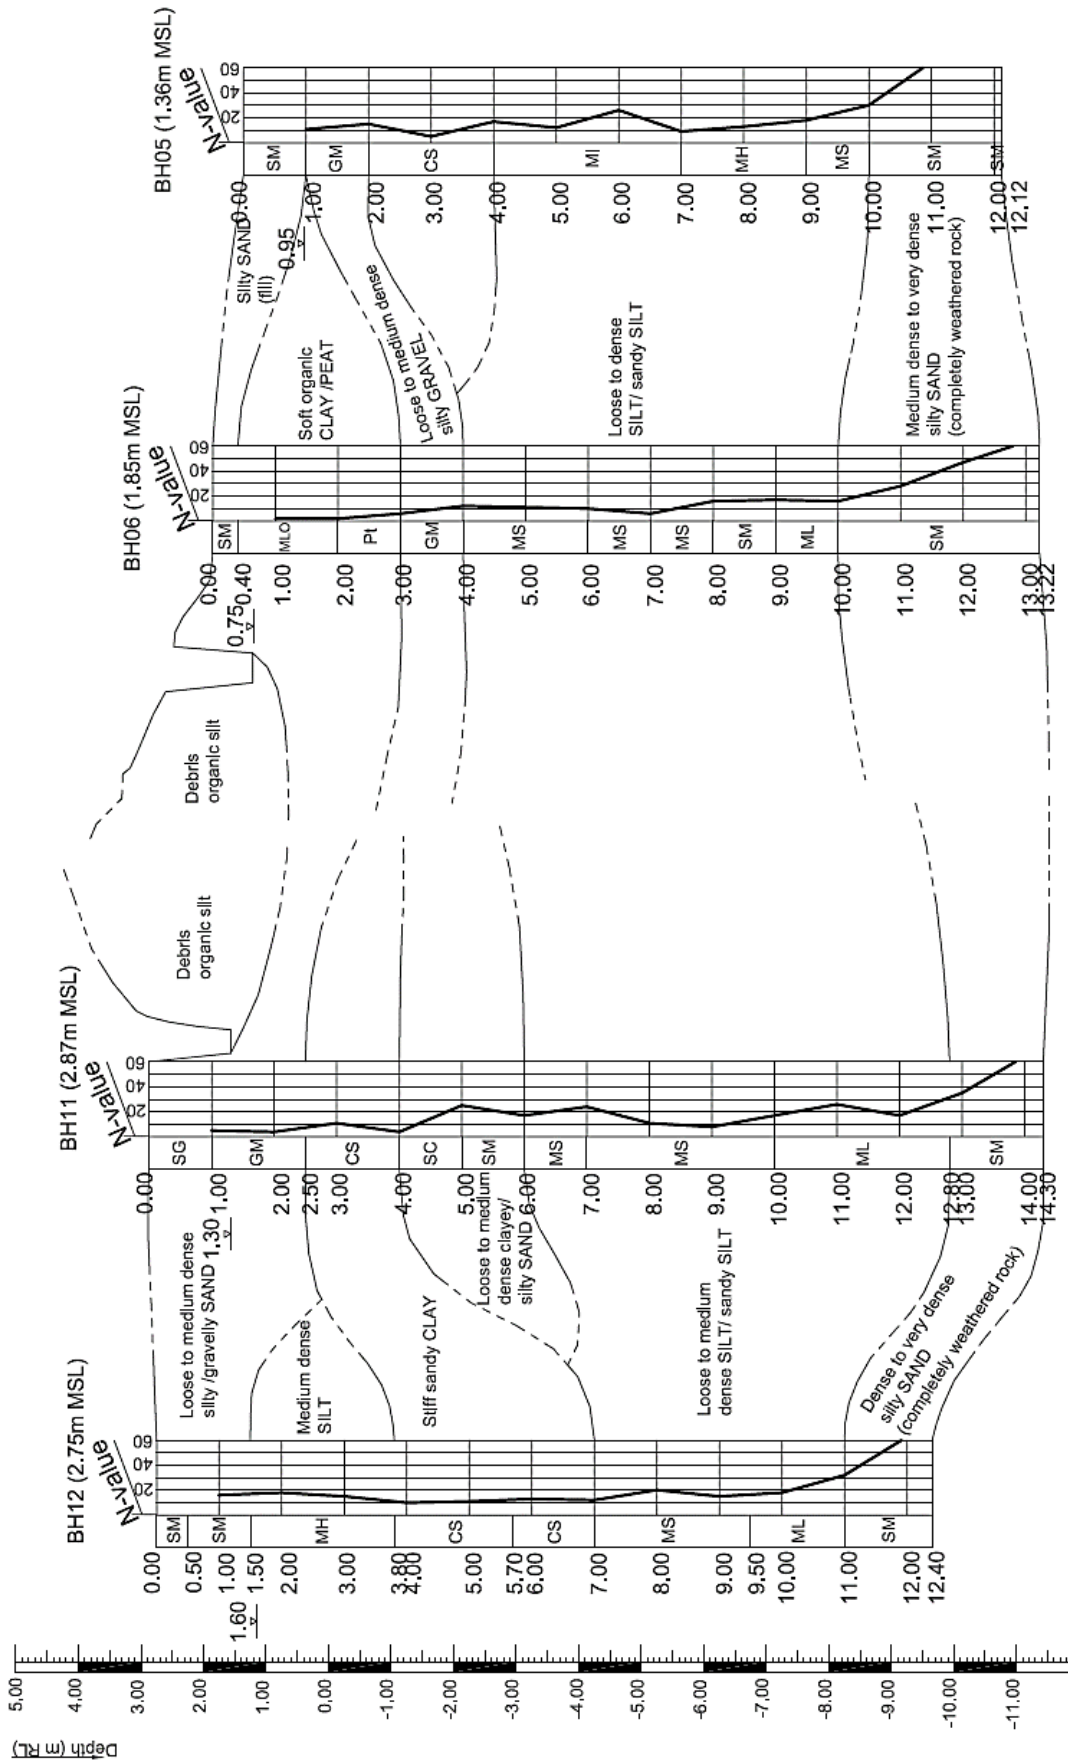
Annexure I: Subsoil profile drawn from the geotechnical investigations done in 2012/2013 at Meethotamulla waste fill site
