# REDUCTION OF LANDSLIDE VULNERABILITY BY MITIGATION MEASURES PROJECT

Site Specific Environmental and Social Management Plan

## Site No. 22- Package 7

Galle - Deniyaya - Madampe Road at 77+100

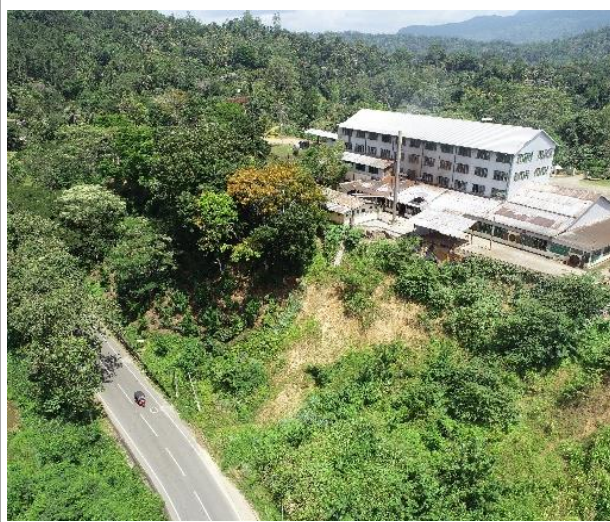
Figure 3: Slope failure along Galle - Deniyaya road

With the heavy rain on 25.05.2017 the down slope of the road has collapsed with a part of the road. Slope failure is possible under extreme weather conditions as surface run off is directed to the collapsed slope due to blocking drain. Part of the road already collapsed, locate at higher risk for future slope failure. As the house is locate closer to the unprotected earth cut, the householders and the house itself are at higher risk. Non-structural mitigation measures are not capable of preventing or minimizing future failures.

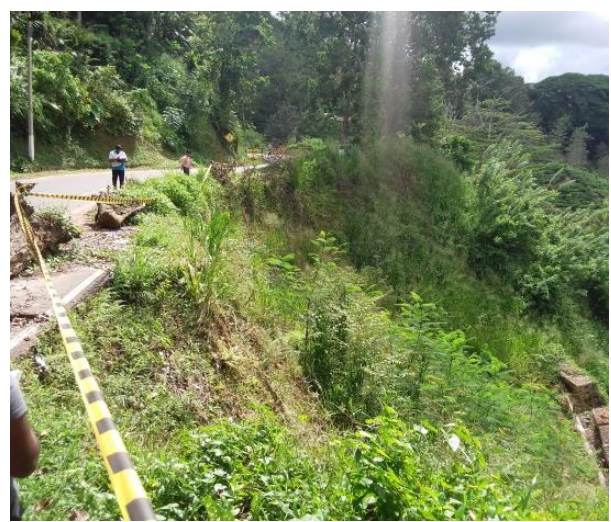
Figure 4: Damaged to road due to slope failure
