# REDUCTION OF LANDSLIDE VULNERABILITY BY MITIGATION MEASURES PROJECT

Site Specific Environmental and Social Management Plan

## Site No. 19- Package 7

## Semidel Gowipala Kanda

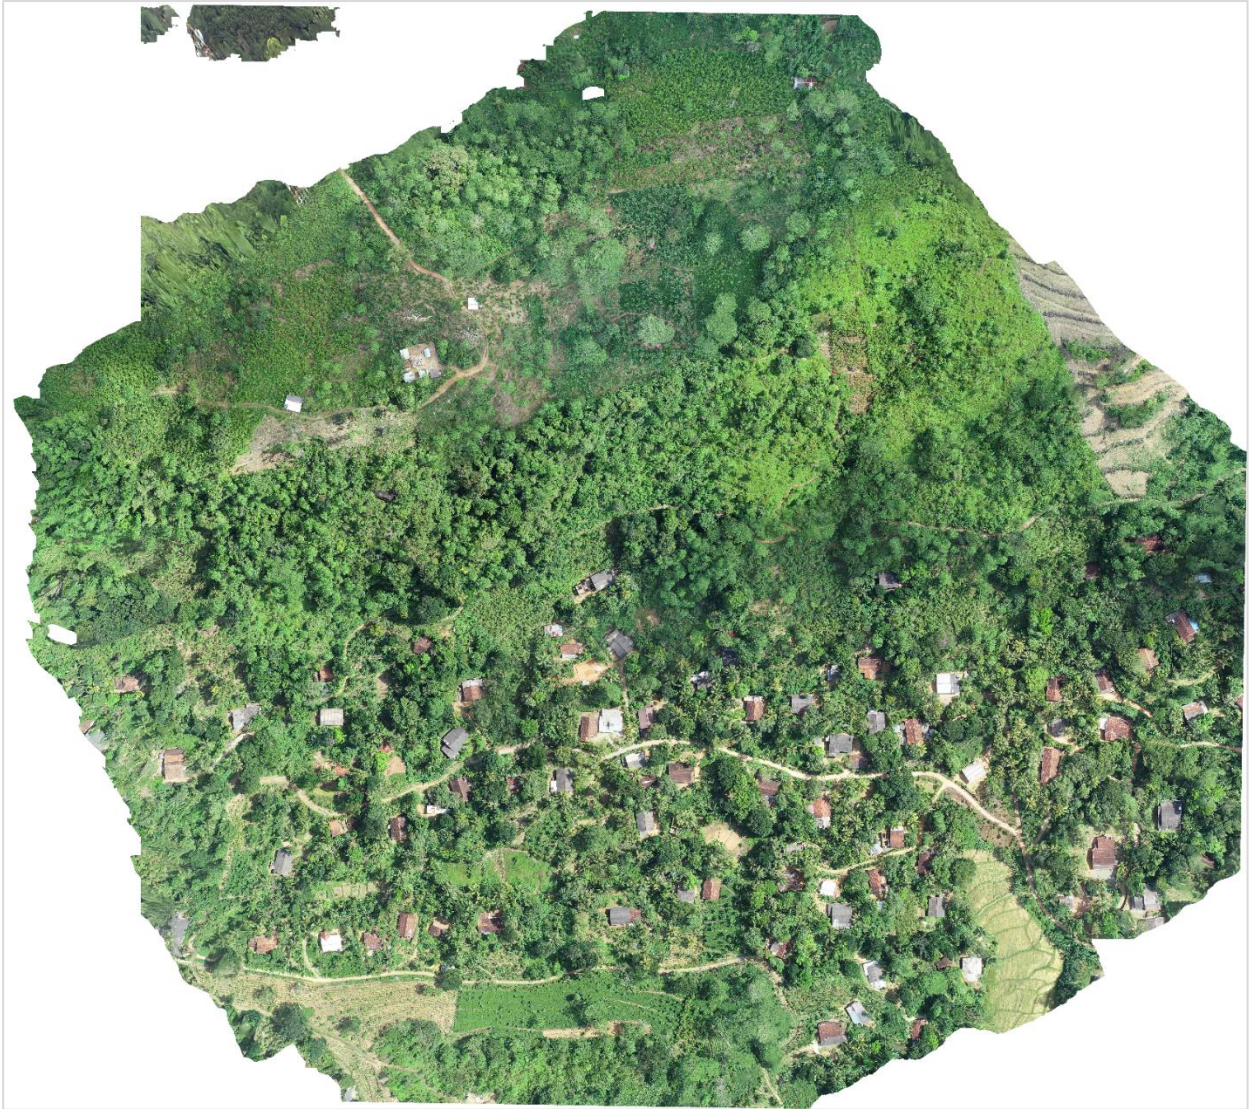
*Figure 2: Drone image of the site*

Landslide occurred in 2016 in this location. Major issues in this area is cutting failure at exposed earth cuts, potential failure throughout the valley, rock boulders failure, transitional failures and wedge failures from fresh rock. Covering an area of 28 – 50 acres, 91 households are in a high risk area for landslide events.

- Construction of surface drainage system including cut off drain and cascade drains
- Provision of horizontal drains
- Reforestation
- Construction of retaining structures (rock fence)
- Control basting
- A community-based landslide early warning system need to be implemented

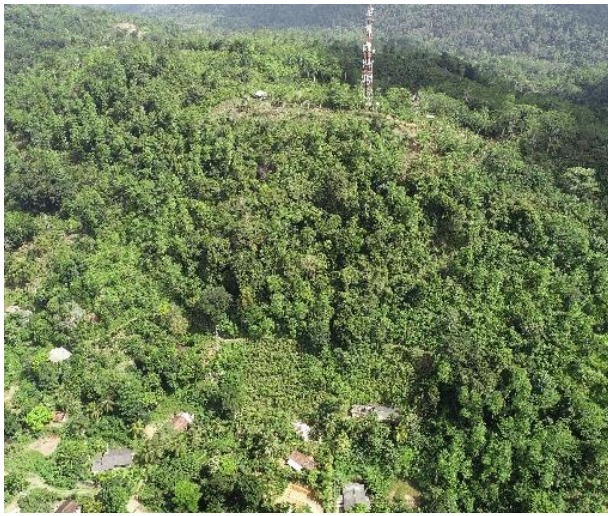
Figure 3: Exposed surface of failed slope

- General slope of area – 12° - 80°
- Type of soil- Residual soil - thickness - 3m - 8m
- Colluvium soil- thickness - 2m - 4m
- Observed in-situ boulders in slope - High Density
- Bed rock exposed at upper slope and weathered rock boulders were observed on the bed rock exposure area
- Loose to medium dense sandy silt soil with associated clay brand was observed at area.
- Water table- Seepages were observed from Earth cut
- Rate of water flow - High
- Natural Valley paths were observed in this area
- Collapsed debris has observed throughout valley path - size - L - 10m, W - 5m
- Earth cutting failure observed at near houses

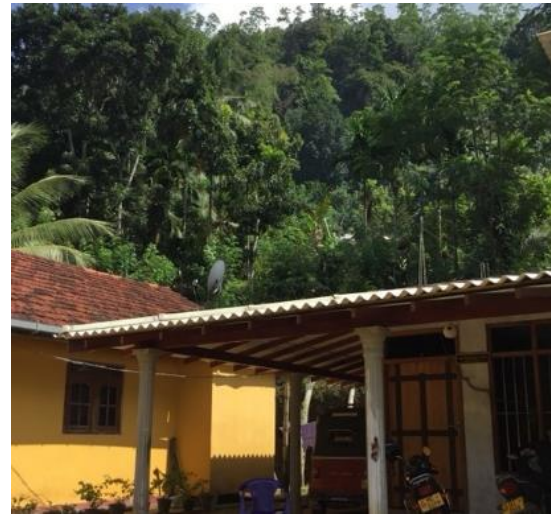
Figure 4: House in potential slope failure area

NBRO had inspected the site and demarcated the risk zone and alerted the occupants of 91 houses who are residing in the area facing landslide risk. The NBRO team has demarcated the houses at high risk and advised the occupants to respond to rainfall early warning system. Awareness was conducted on preparedness and evacuation alerts were given. This mechanism is currently operational by the Gram Niladhari in the division via Division Secretary.
